Barton-Upon-Irwell

Conservation Area Appraisal
Consultation Draft
April 2016

Barton-upon-Irwell Conservation Area Conservation Area Appraisal

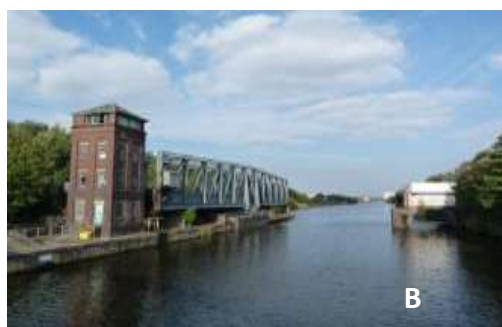
- 4.3.3 The aqueduct that carries the Bridgewater Canal and the road bridge lie adjacent to each other, crossing the span of the Manchester Ship Canal and the man-made island which has the control tower at its centre and the pier on which both bridges are mounted.

B Aqueduct in the open position

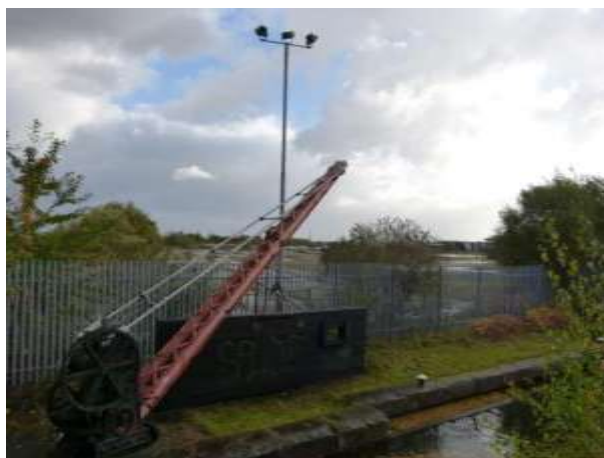
- 4.7.4 A former loading platform on the south bank of the Ship Canal is still evident and in good condition although all associated machinery and apparatus has been removed. A small crane sits on the eastern side of the Bridgewater Canal, to the immediate south of the aqueduct.

Crane at south end of aqueduct

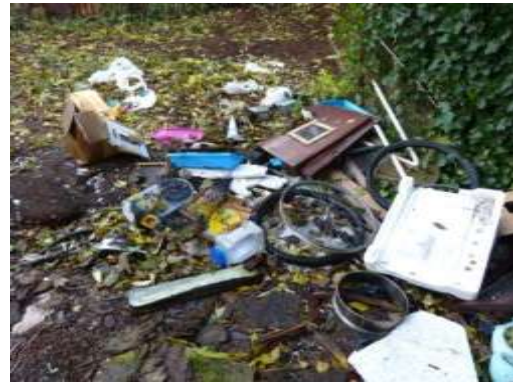
- 4.8.16 The public realm is extensive and there is a variety of hard landscaping in the Conservation Area. Herringbone block paving has been used to surface Old Barton Road and Chapel Place. Chapel Place was landscaped in the 1980s and the pathway, which follows the line of the former street and provides access to the Bridgewater Canal, has brick paving with seating and a metal gazebo. However, the area is adversely affected by fly tipping and vandalism.

Fly tipping off Chapel Place

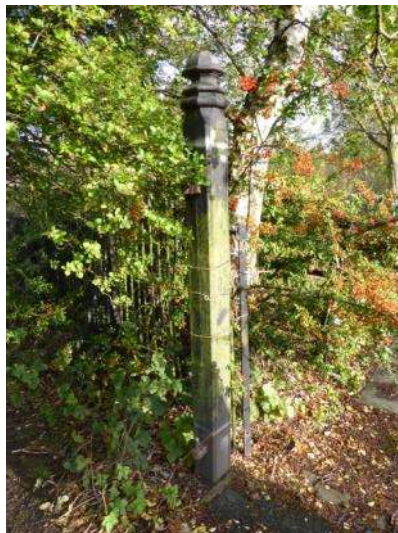
- 4.8.18 The remnants of older gate posts and fence posts can still be seen throughout the public realm areas although these are gradually deteriorating and returning to nature.

Old gate post off Old Barton Road

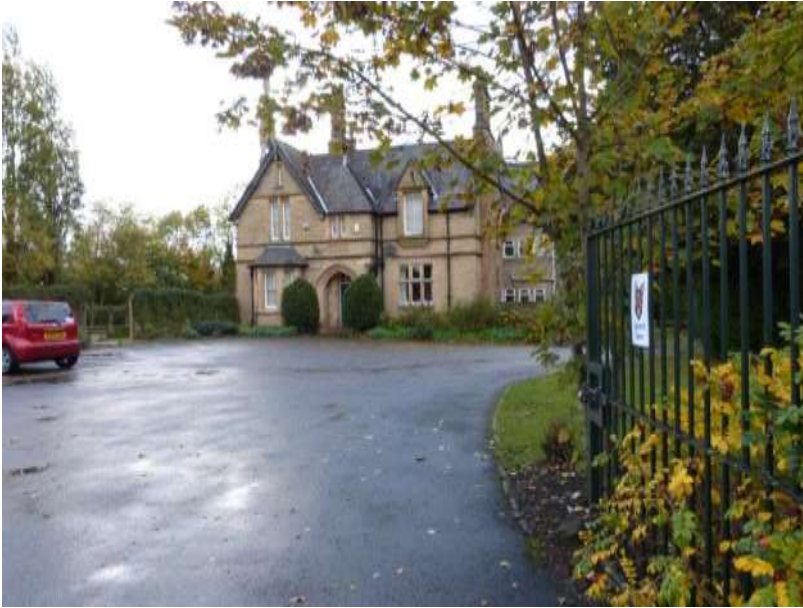
All Saints Presbytery

Date: 1867-68

Condition: Good

the associated church but of simpler detailing. The building is also in private ownership and appears to be well maintained. One ridge tile insert is missing and one chimney pot. Both should be reinstated. There is some unsuitable piping running up the front elevation and roof valley which is detrimental to the building.

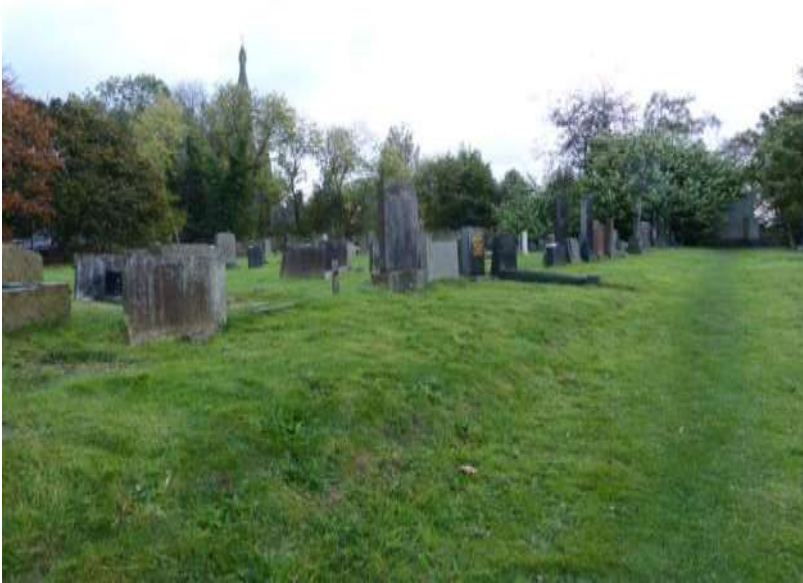
Gravestones in St. Catharine's Graveyard

Date: Various

Condition: Fair
