# Warburton Village Conservation Area

Conservation Area Appraisal  
October 2016

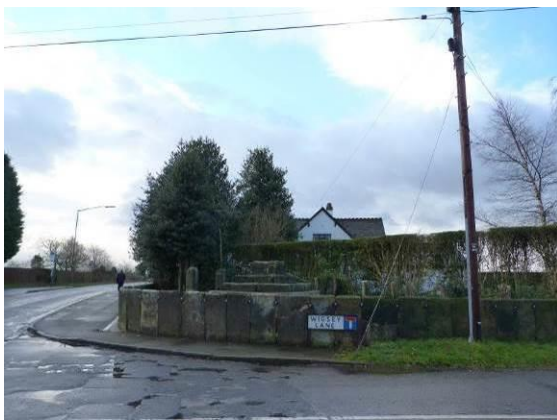
*Flagstone enclosure containing the stocks and cross base*

- 6.2.8 The steps of the historic stone cross base to corner of Wigsy Lane and Townfield are in poor condition and require conservation, with moss growth, open joints and dislodged and cracked masonry noted. The historic stocks located in front of the steps have several visible fractures to the stone piers with various iron cramps to hold in them place. Modern steel has been strapped to stop the top of left hand side pier where there is a large vertical crack.

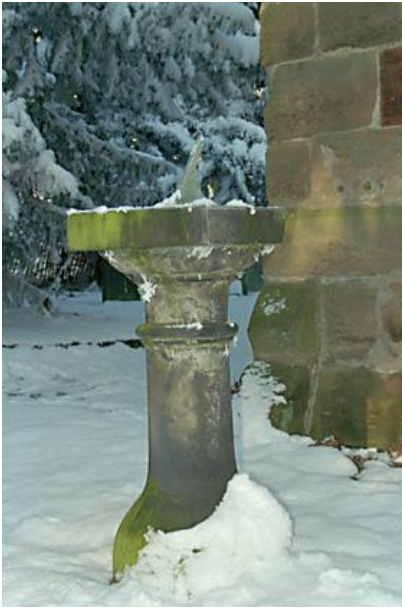
**Sundial to south-west of old Church of St Werburgh, Wigsey Lane**

**Date:** 1765 (on dial)

**Condition:** Fair

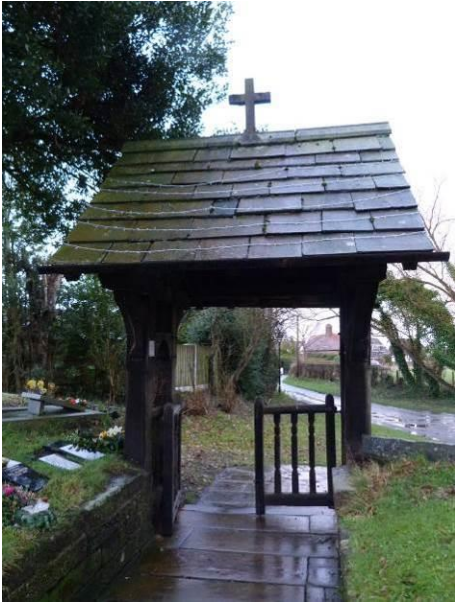
**Lychgate, Old Church of St Werburgh, Wigsey Lane**

**Date:** Late 19<sup>th</sup> century

**Condition:** Good

The timber-framed lychgate is believed to date from the late 19<sup>th</sup> century and stands over an early, probably original, entrance route into the churchyard. Its design echoes the Arts and Crafts style found throughout the village with its chunky timber beams and braces, slate roof and simple turned balusters.

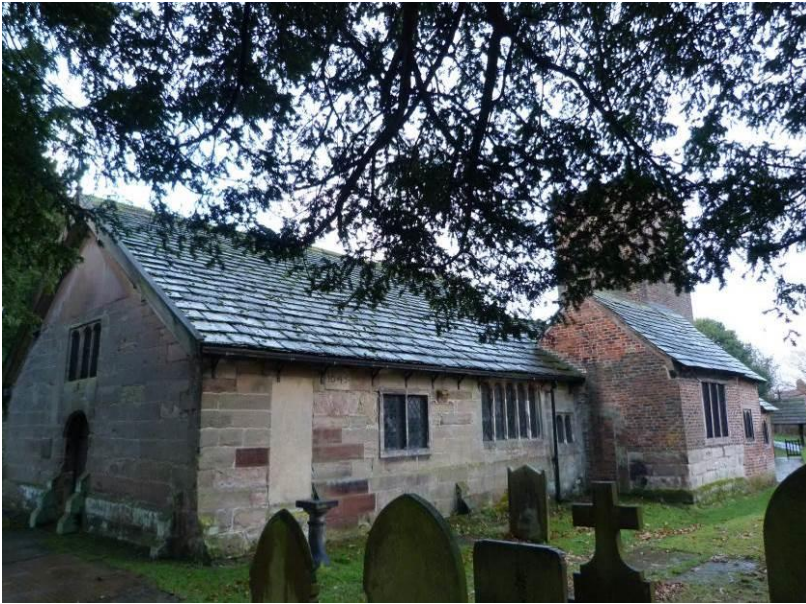
### Old Church of St Werburgh's, Wigsey Lane

**Date:** Mostly reconstructed in early 17<sup>th</sup> century with older fabric incorporated and later additions

**Condition:** Good

The church is a highly unusual combination of timber frame, masonry and brick construction, and there are clear indications in the surviving fabric of multiple phases of alteration. Areas of pointing between the brickwork have evidently been replaced in recent years and the roof slates are well-appointed, indicating that the roof has undergone recent repair.

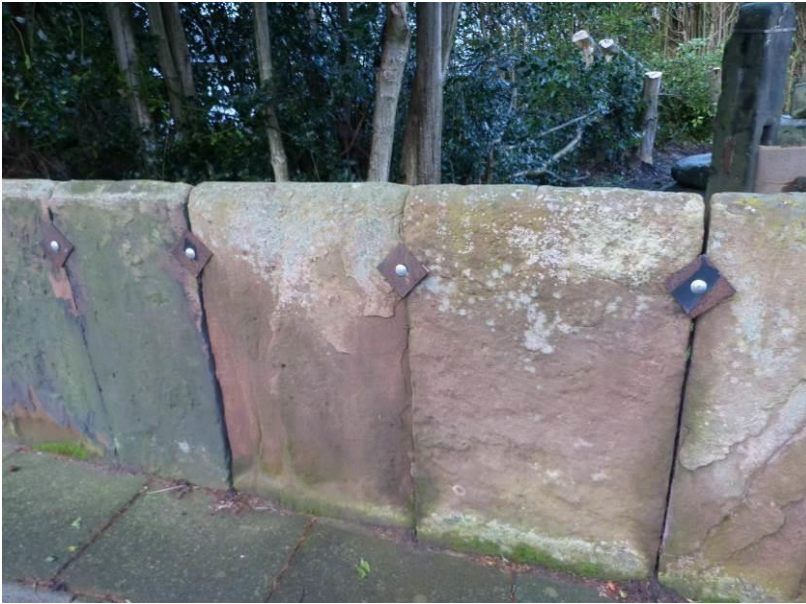
**Stone flag wall around old stocks and cross, Townfield Lane (B5159)**

**Date:** 18<sup>th</sup>/19<sup>th</sup> century

**Condition:** Fair

The use of upright locally-quarried flagstones is characteristic of the boundary treatments throughout the Conservation Area and adopted boundary extensions. Those here have undergone repair in recent decades and are now held together with cramps. The wall is significant as a prominent example of a local detail and the length of flagstone walling along Wigsey Lane is covered under the same listing, although this section of walling is not in as good condition.

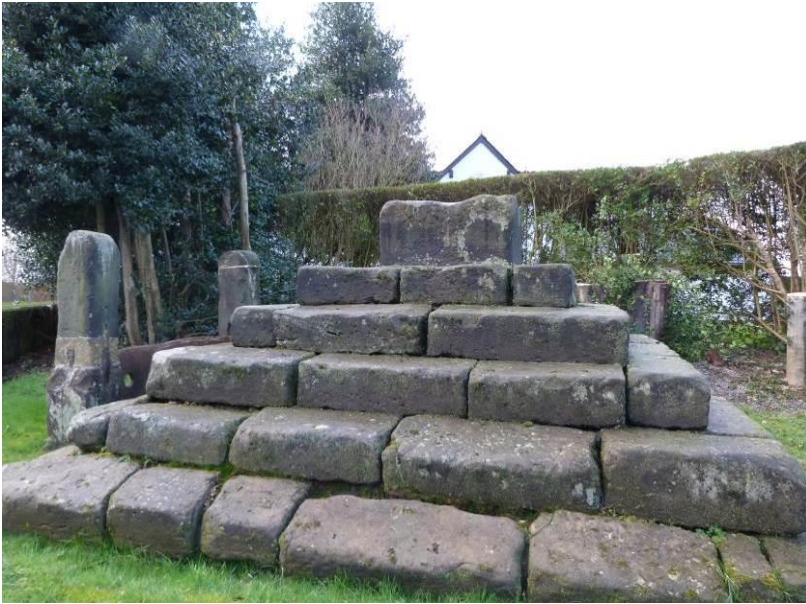
**Cross base south of Townfield Lane (B5159) junction with Wigsey Lane**

**Date:** Unknown

**Condition:** Fair

The date of the cross base is completely unknown and there is no known reference of the cross that is believed to have stood at the top of the raised structure. It is clear from cartographic evidence that the cross base formerly stood on the opposite site of the crossroads, on the green north of Townfield House. It is comprised of hewn blocks of a local hard sandstone piled into a pyramidal structure (the lower levels of which are worn and uneven), with no evidence of any pointing.

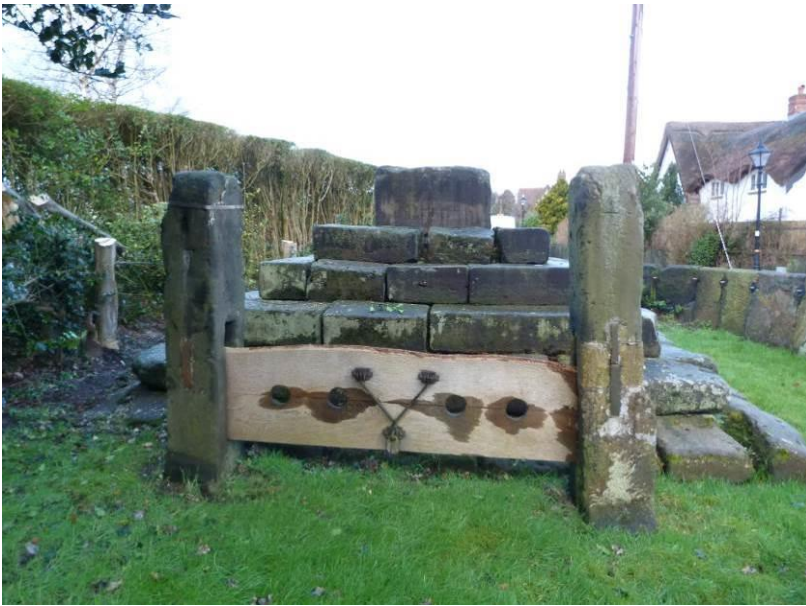
### Stocks south of Townfield Lane (B5159) junction with Wigsey Lane

**Date:** Possibly 17<sup>th</sup> century

**Condition:** Fair

The stocks are believed to date from the 17<sup>th</sup> century and underwent restoration in around the early 20<sup>th</sup> century; iron cramps are evident where repairs have been made. It is not clear whether the stocks were always located here, although given their prominent position it is likely that they were. The wooden stocks with holes for securing feet are not original.

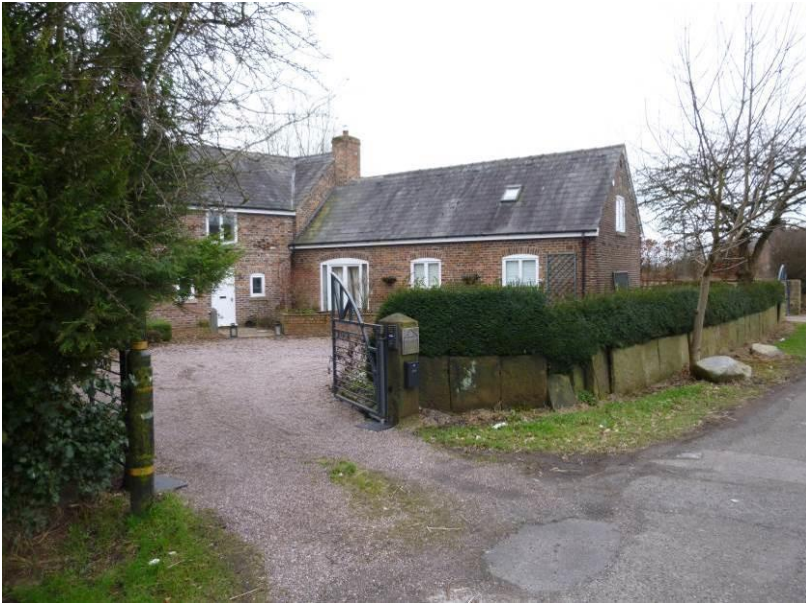
**Wigsey Cruck (listed as 'Shippon to west of Wigsey Farmhouse'), Paddock Lane**

**Date:** 18<sup>th</sup> century

**Condition:** Good

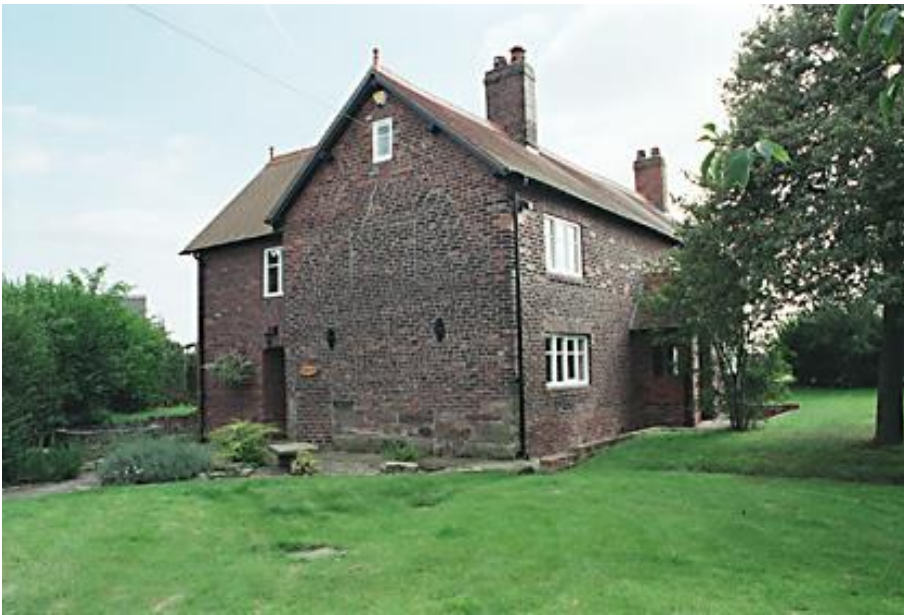
### Wigsey Farmhouse, Paddock Lane

**Date:** 17<sup>th</sup> century

**Condition:** Good

Wigsey Farm was one of a number of historic farmsteads in Warburton. The farmhouse has a 17<sup>th</sup> century core and has undergone a number of alterations and additions in the ensuing centuries. As is characteristic of the village, this includes Arts & Crafts style detailing such as the looped ridge tiles.

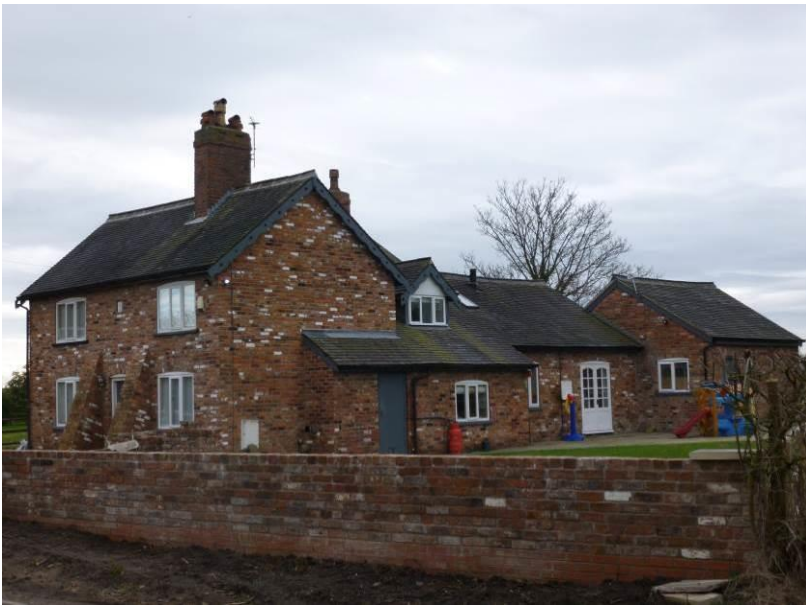
### **Paddocklake Farmhouse, Paddock Lane**

**Date:** 18<sup>th</sup> century

**Condition:** Good

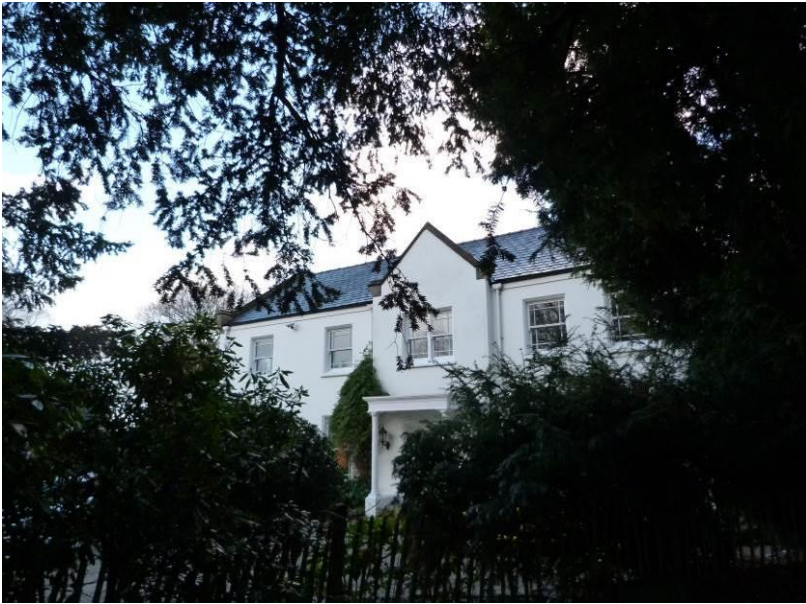
### **Old Rectory, Wigsey Lane**

**Date:** Rebuilt 1838

**Condition:** Good

**Reason:** The 1838 Old Rectory has recently undergone an extensive overhaul, including the installation of UPVC windows and a white render. It is included as a positive contributor for its historic significance and connections with the neighbouring church.

6.2.2 The Old Rectory is set back from road and is now a private residence so it was not possible to fully inspect the building. The building appears to be well maintained, though the majority of windows replaced with modern units. There are two small, independent brick buildings in the grounds of the rectory, possibly garages, both of which also appear to be in good order.

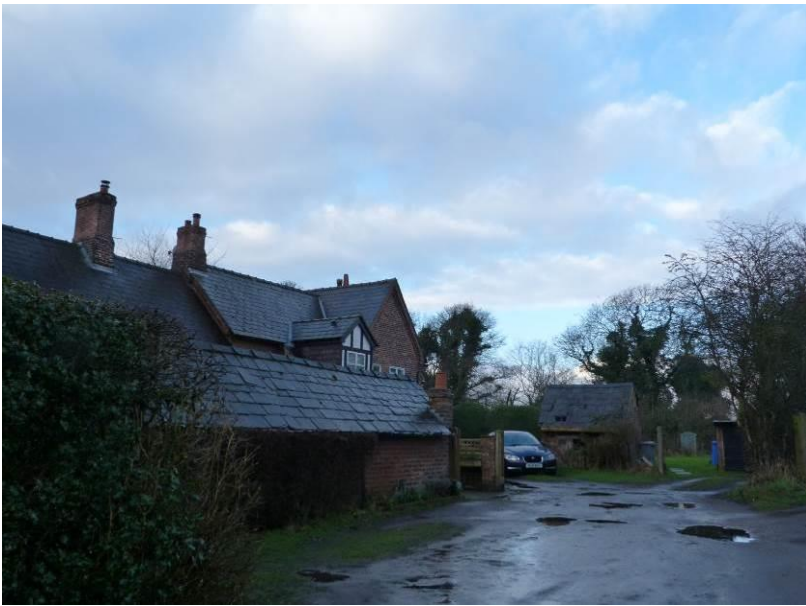
### 7-10 Church Green, Former Pipe & Punchbowl Alehouse

**Date:** 18<sup>th</sup> Century

**Condition:** Good

**Reason:** Now a terrace of residential cottages, the former alehouse is a positive contributor for its local detailing, including its prominent gables and quality brickwork. Its group contribution together with Fir Tree Cottage and Laburnum Cottage is especially notable.

6.2.3 The terrace of four properties to the west of Wigsy Lane (Nos. 7-10) are occupied and reasonably well maintained. The windows have all been replaced with modern casements. The slate roof to the adjacent outbuilding is in poor condition with multiple slipped slates.

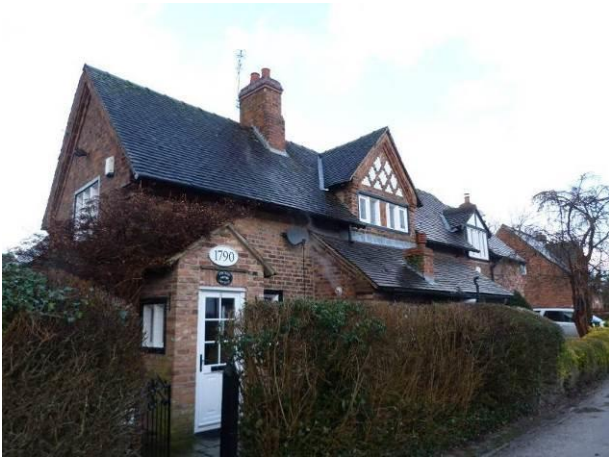
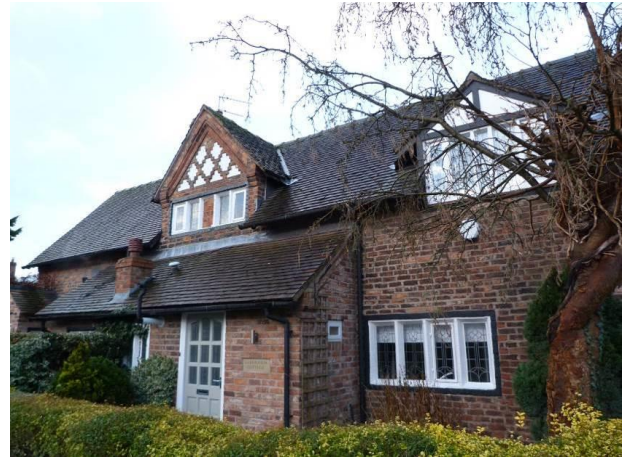
### Fir Tree Cottage and Laburnum Cottage, Church Green

**Date:** 18<sup>th</sup> Century

**Condition:** Good

**Reason:** Included for their well-maintained appearance and retention of Arts and Crafts style detailing including decorative gable brickwork. As is characteristic of the Conservation Area, the cottages have large gable dormers on the first floor. Their group contribution with 7-19 Church Green is especially notable.

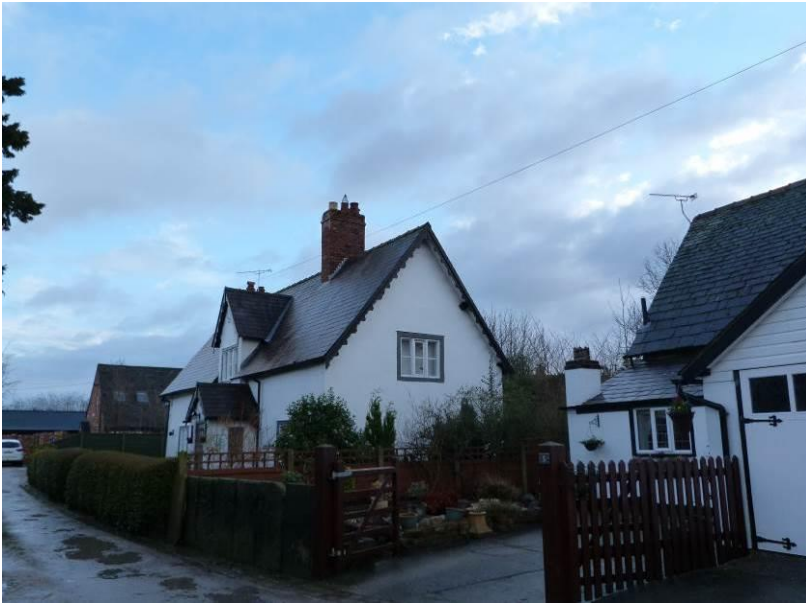
### September Cottage, Church Green

**Date:** 17<sup>th</sup> Century with later alteration

**Condition:** Good

**Reason:** Included for its group value with 3 Wigsey Lane. The exterior of the cottage has been maintained to a very high standard and the building consequently looks considerably newer than its early construction date. It is notable for its retention of its decorative 19<sup>th</sup> century barge boarding and tall brick chimney stack. Given its 17<sup>th</sup> century date this building could be considered for listing.

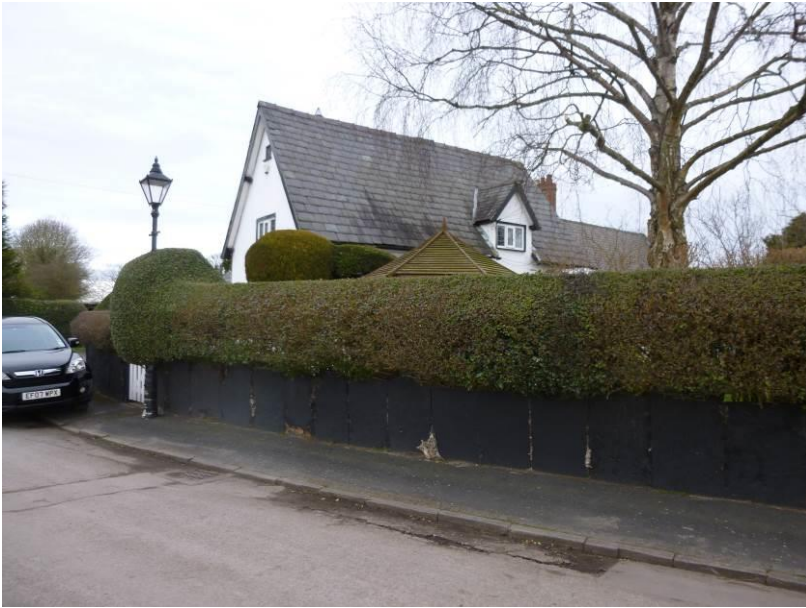
### 3 Wigsey Lane

**Date:** 18<sup>th</sup> Century

**Condition:** Good

- 6.2.5 No.2 Wigsy Lane appears to be well maintained. However, the walls have been poorly re-pointed with cementitious mortar. No.3 Wigsy Lane has some cracking to the render and the windows have been replaced with UPVC casements. There are several slipped and cracked slates and the render has detached from the chimney in several locations. All the chimney pots have been removed.

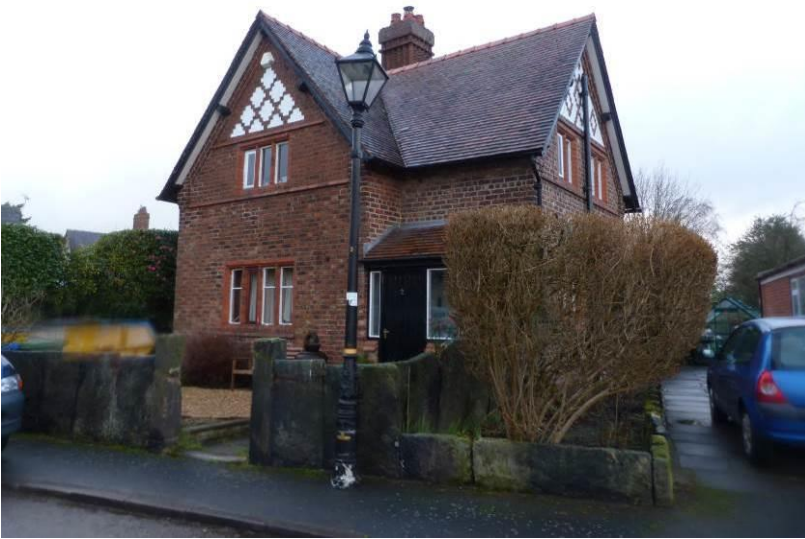
## 2 Wigsey Lane

**Date:** 19<sup>th</sup> Century

**Condition:** Good

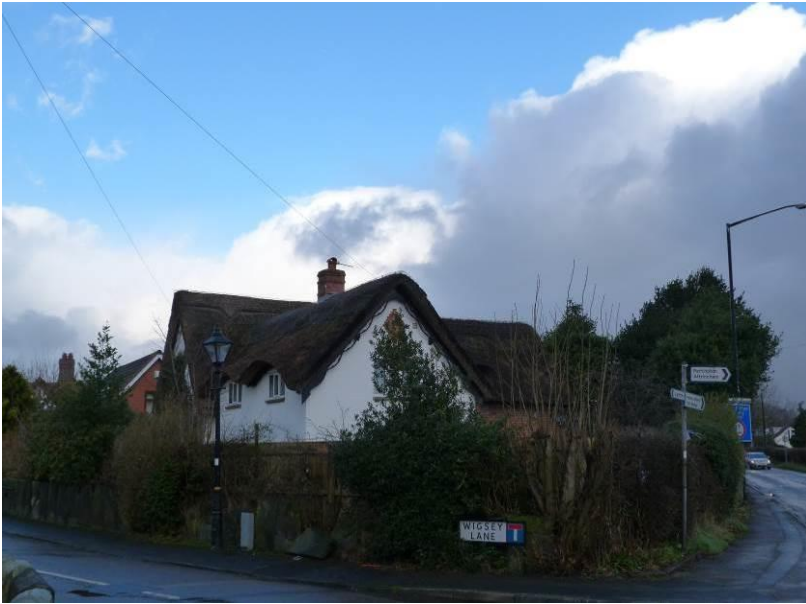
## 1 Wigsey Lane

**Date:** 17<sup>th</sup> Century with much later extensions

**Condition:** Good

**Reason:** 1 Wigsey Lane is the only thatched building in the Conservation Area and adopted boundary extensions. Although substantially extended, it contains a 17<sup>th</sup> century core so is innately historically significant. Thatch is a traditionally rural building material, thus the building suits its context well. Echoes of Warburton's characteristic Arts and Crafts fashion are evident in the barge boarding that has been installed under the thatched gable ends. Given its 17<sup>th</sup> century date this building could be considered for listing.

- 6.2.4 No.1 Wigsy Lane is a two-story thatched property. All the windows have been replaced with the UPVC casements and modern render has been applied. There are several pargett plates to the west elevation which would suggest previous spreading to the outer walls.

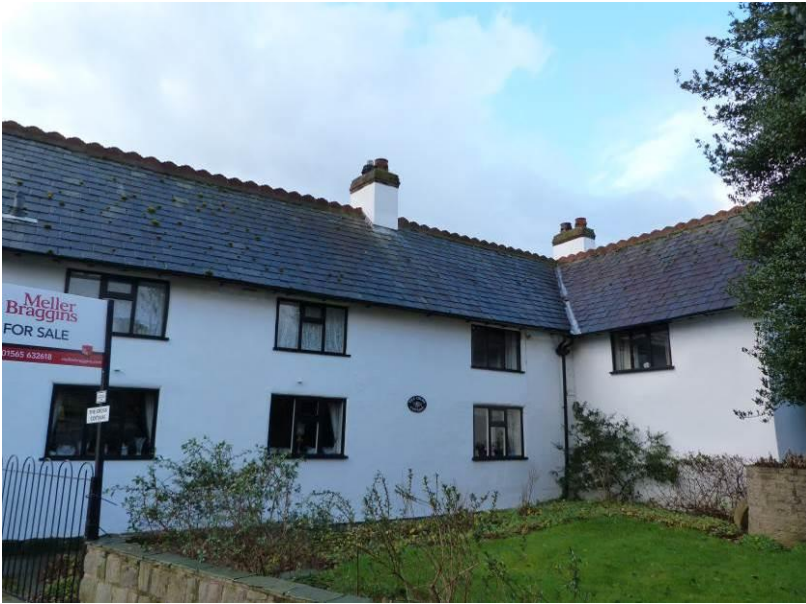
### The Cross Cottage, Townfield Lane

**Date:** 18<sup>th</sup> Century

**Condition:** Good

**Reason:** So named due to its proximity to the cross base, The Cross Cottage is another building with nods to the Arts and Crafts style with its scallop ridge tiles. Although it has a different roof covering, the white render compliments well that of 1 Wigsey Lane opposite, contributing to their group value.

- 6.2.9 Cross Cottage located to the south of the cross is a two-storey property, which has modern rendered elevations and a slate roof with crested ridge tiles and modern timber casement windows. The render and roof appear in good condition. A sandstone plinth is visible to corner of property.

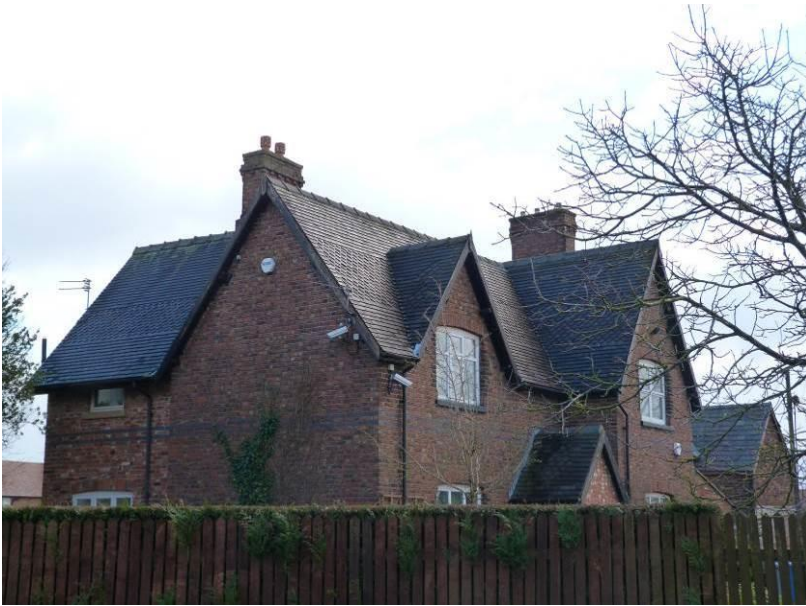
### Townfield House, Townfield Lane

**Date:** 19<sup>th</sup> Century

**Condition:** Good

**Reason:** Townfield House is notably larger in scale than most buildings within the Conservation Area and the adopted boundary extensions. Its slightly detached position means that this does not negatively impact on the typically smaller dwellings at the east and west ends of the adopted enlarged Conservation Area. With an assortment of gables and varied roofline, it has clear connections with the village's characteristic Arts and Crafts style yet adds to the architectural variety.

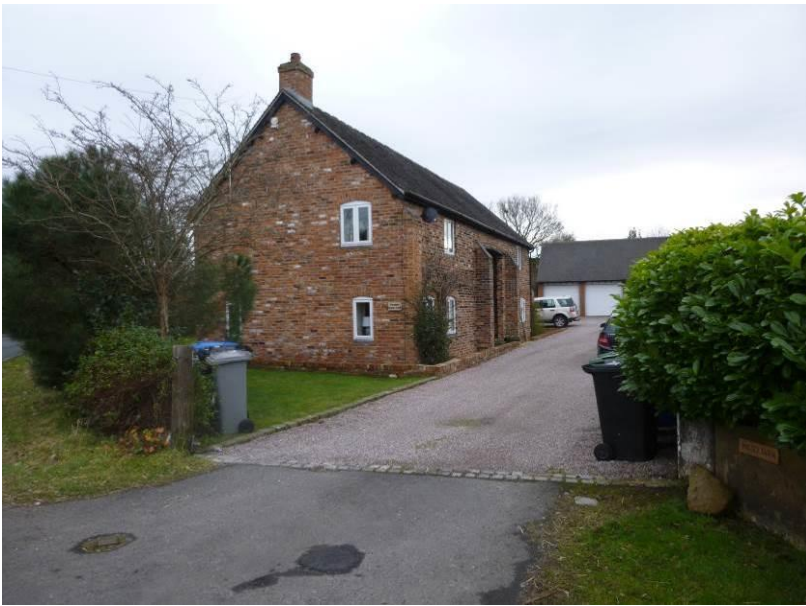
### The Barn at Wigsey Farm, Paddock Lane

**Date:** c.19<sup>th</sup> Century

**Condition:** Good

**Reason:** As the name suggests, The Barn at Wigsey Farm is a barn converted into a private dwelling in the mid/late 1990s. An attractive and well-maintained building, it has retained its traditional simple form, remaining architecturally secondary to the main farmhouse. It is particularly notable for its group contribution with Wigsey Farmhouse and Wigsey Cruck.

- 6.2.13 The barn at Wigsey Farm is located at right angles to road and was not available for full inspection, though it appeared well maintained. Paddock Lake Farm has been heavily renovated and modernised with little left to suggest of this date. It is in good condition. The adjacent Pasture View has a timber frame visible to the front elevation with a sandstone plinth. It has been poorly re-pointed with several service vents passing through the external wall. Joined to this is Church View, of which only the brickwork rear elevation is visible, with nothing to indicate a cruck frame. There is a vertical joint to the centre of the elevation with an outward lean to the left hand side, though this appears historic with no recent movement.

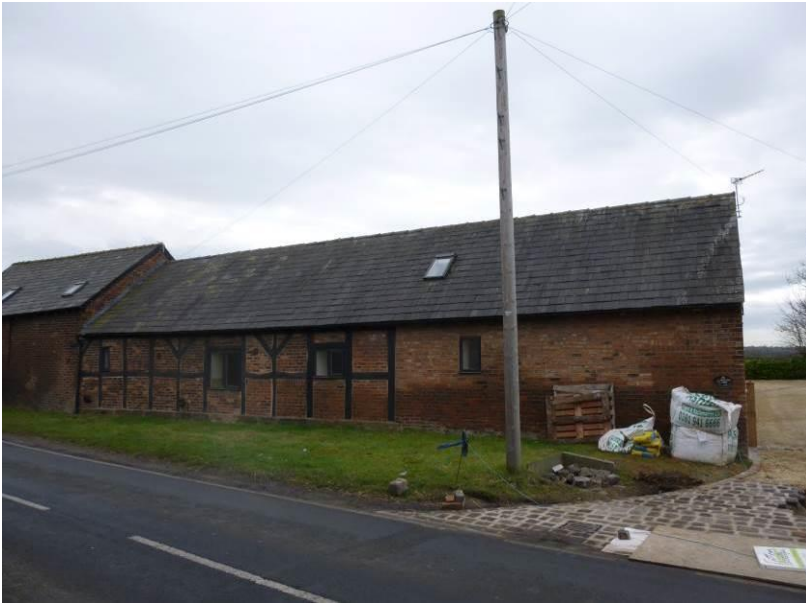
### Pasture View and Church View, Paddock Lane

**Date:** 18<sup>th</sup> Century

**Condition:** Good

**Reason:** The low, longitudinal form of these buildings indicate that they were originally 18<sup>th</sup> century livestock shelters and have an innate historic value. They are attractive and well-maintained buildings, and are particularly notable for their group value both together and with the neighbouring Paddocklake Farmhouse. The use of dark stained timber window frames is especially appropriate and matches the dark stain of the timber frame.

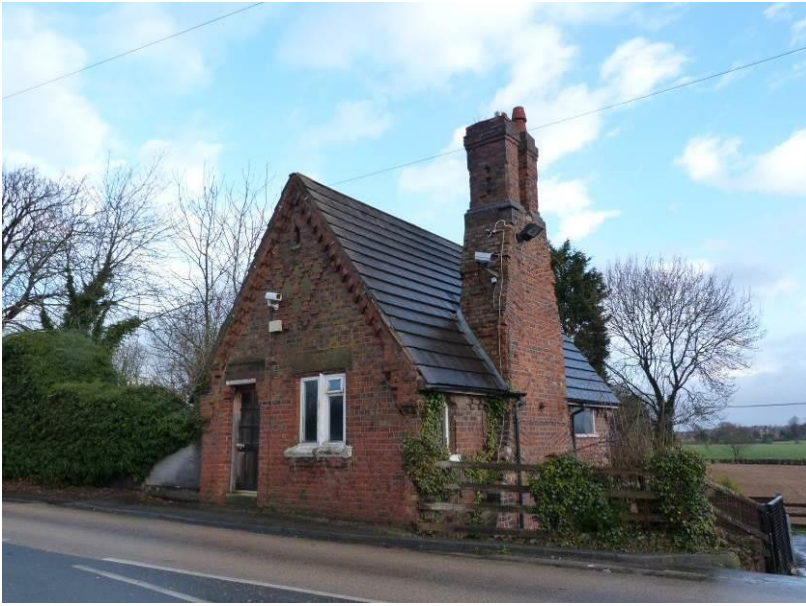
### **Toll Cottage, Warburton Bridge Road**

**Date:** Late 19<sup>th</sup> Century

**Condition:** Fair

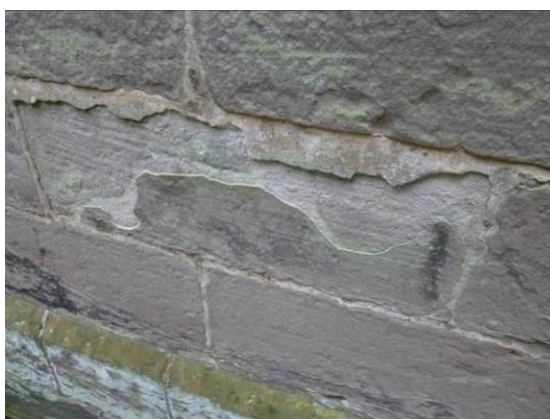
6.2.1 Saint Werburgh's Church generally appears well maintained. There are some slipped and cracked roof slates, with heavy moss build up to the north roof slopes. Elevations are well maintained but with moss and algae build up to the plinth level. There are some areas of cementitious re-pointing, including to window surrounds in the timber framing. The stone walling is de-laminating in many locations. The timber lychgate at the entrance to the church yard is in generally good condition, other than some braces which have shrunk and rotated.

*Example of delamination to ashlar on St. Werburgh's Church*

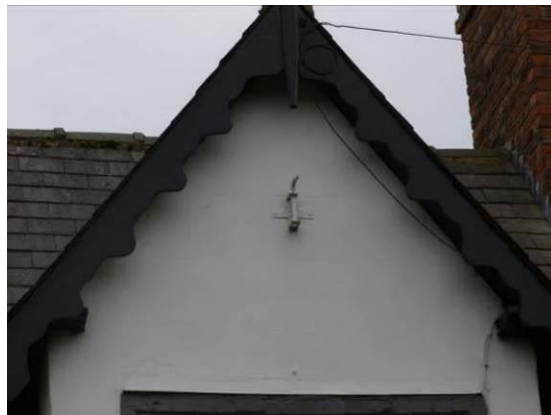
- 6.2.7 Nos.4A, 4B and 5A Church Green appear to be relatively modern additions, designed to imitate the adjacent buildings. They are well maintained. Nos. 5 and 6 form a pair of cottages, all of which appear generally well maintained. There is cementitious pointing to the brickwork and some slipped tiles.

*Incised joints to render of No.4 Church Green dormer gable*

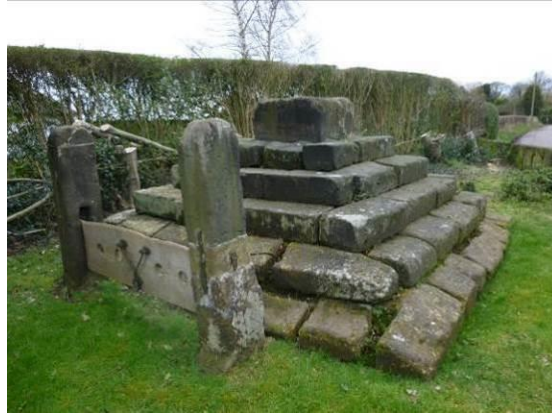
*Dislodged steps to cross base and cracks to stocks*

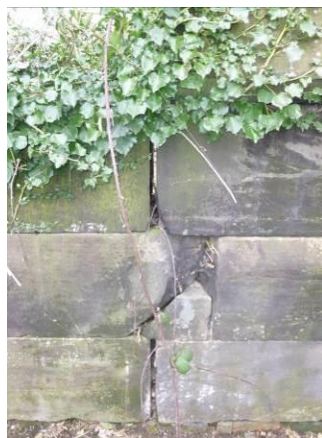
- 6.2.11 The toll bridge to the north of the toll hosue have balustrade walls of large sandstone ashlar blocks and pitched copings. The majority of the walling is covered by vegetation. Where visible, cracking and damage was noted to blocks, as well as several dislodged blocks and eroded mortar joints generally. To the east side of the road there is a good quality iron railing running between the two bridges. Again this is mostly obscured by vegetation. However, where visible some fractures and some temporary repairs were noted. The ironwork urgently requires prepping and decorating and all vegetation should be stripped back.

*Crack and vegetation to bridge balustrade wall*

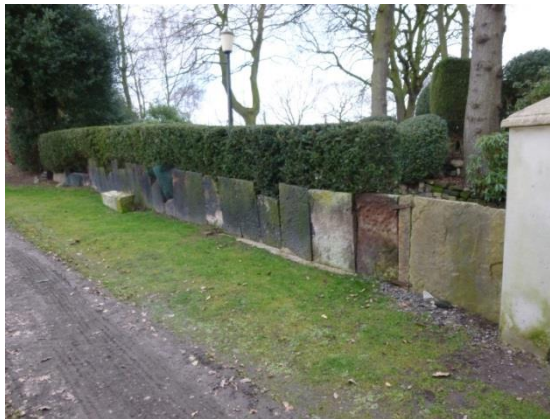
- 6.2.14 The ashlar stone wall to the church boundary has some damaged coping stones which require repair. The vertical stone slab wall to the Old Rectory boundary is in poor condition with several slabs cracked or broken.
- 6.2.15 Boundary walls to Wigsey Lane also of vertical stone flags. These are poorly maintained to No.1 and have gone to ruin towards the east edge. The flags have been cut in half to No. 1A. Those to the boundary of No. 3 are painted with a black paint, possibly bitumen, which may be causing damage.

*Vertical sandstone flag boundary wall to rectory, with multiple fractured flags*
