The Devisdale Conservation Area Appraisal July 2016

The Devisdale Conservation Area

Bowdon

Conservation Area Appraisal

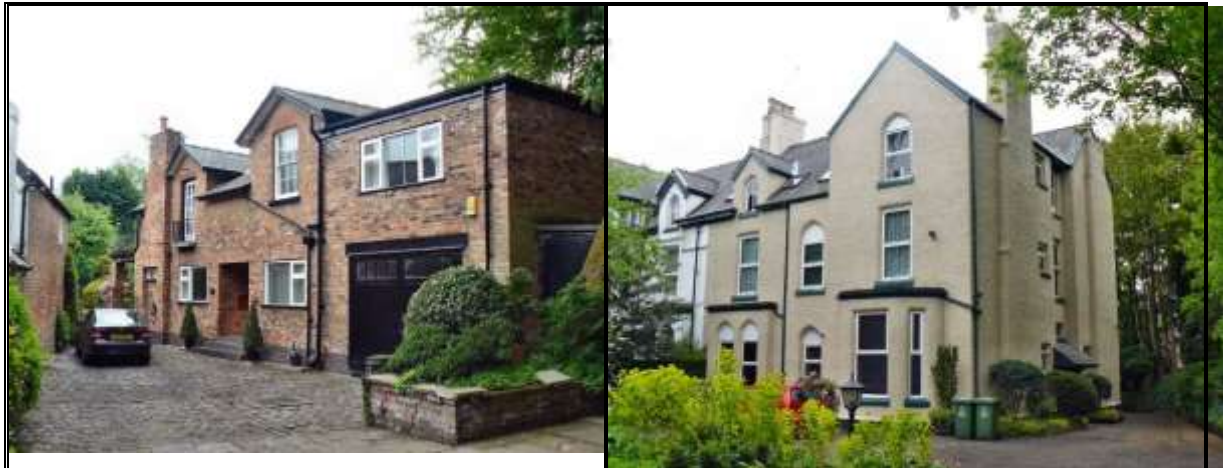
- 4.3.16 Windows are generally of timber but many 20th- 21st century properties have UPVC units. There are some examples of historic properties with unsympathetic UPVC window replacements, such as Grove House Cottage and Harthill on Woodville Road (photographs 14 and 15).

Photograph 14: UPVC Replacement Windows to Grove Cottage

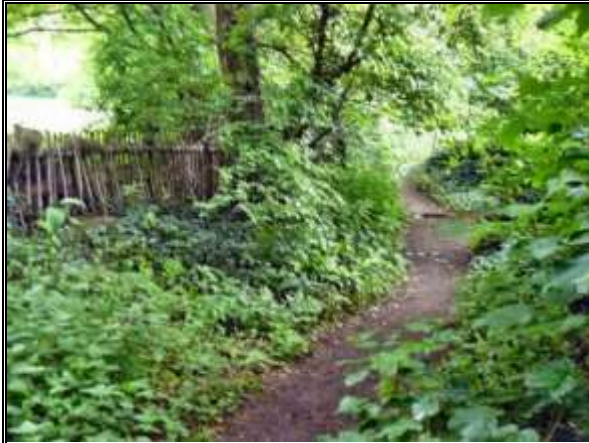
- 4.3.48 The wooded area north of Dunham Road differs in that the fencing is simple chestnut paling fencing, much of it heavily overgrown with ivy and in poor condition (photographs 48 and 49). There is a wooden signpost marking the footpath but the opening in the fence is not obvious. The paths are of earth and do not follow a consistent direction; historic maps show a carriageway along the northern path, whose timber gate is still there but heavily overgrown. The 1971 OS map shows paths around the perimeter. There are no bins, benches or street lighting in this area.

Photograph 48: Path and Chestnut Paling in Woodland North of Dunham Road

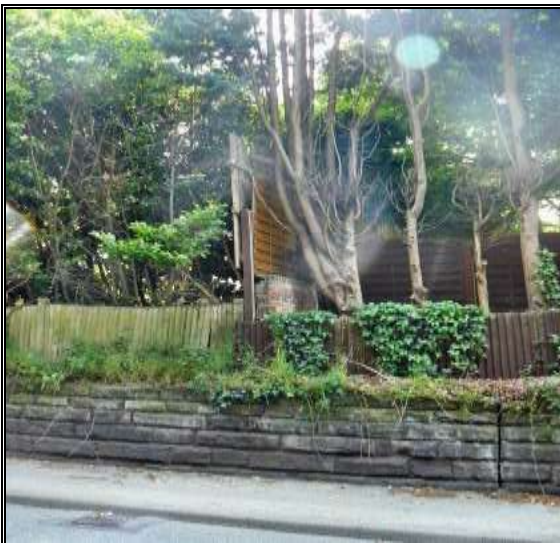
6.2.3 The boundary treatments throughout the Conservation Area are of a variety of styles and ages. Some of these boundary treatments are not of an appropriate design, such as high modern brick walls, modern timber panel fencing and tall metal railings. The piecemeal boundary treatments of different designs are having a negative effect on the character and appearance of the area as there is no sense of visual harmony. The Conservation Area is characterised historically by stone walls with hedge planting and possibly railings above. Where original railings have been lost, some of the replacements have been taller or more ornate, thus diminishing the character of the area. There are also examples of higher stone walls, along Dunham Road (photograph 114) and Bradgate Road for example. A characteristic feature of the higher boundary walls is the existence of attractive arched doorways; however where these are largely unused, they are often in poor repair.

Photograph 114: Combination of Boundary Treatments along Dunham Road.

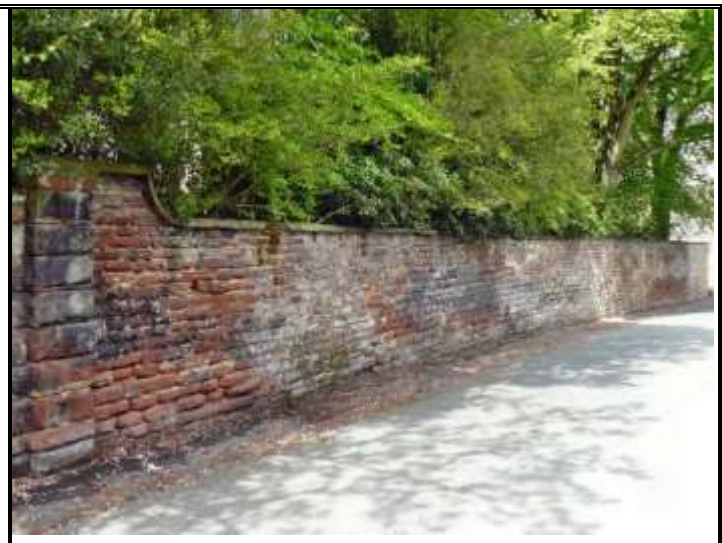
Photograph 115: Damaged Stone Boundary Wall along Gorsey Lane

6.2.4 Every effort should be made to encourage property owners to include these in routine house maintenance, as they are easily overlooked. The integrity of the stone walls themselves is also an issue in some areas, the sandstone wall to the west side of Gorsey Lane is in a state of disrepair as the stone work has spalled (photograph 115). Stone planters on St Margaret's Road have cracked due to the pressure from roots (photograph 117). Chestnut paling is used as a boundary treatment along Dunham Road and Charcoal Road. This is an historic boundary treatment which is today more associated with open space or wooded areas as opposed to the fronts of properties. Along Dunham Road there are areas of chestnut paling that are in need of repair (photograph 118).

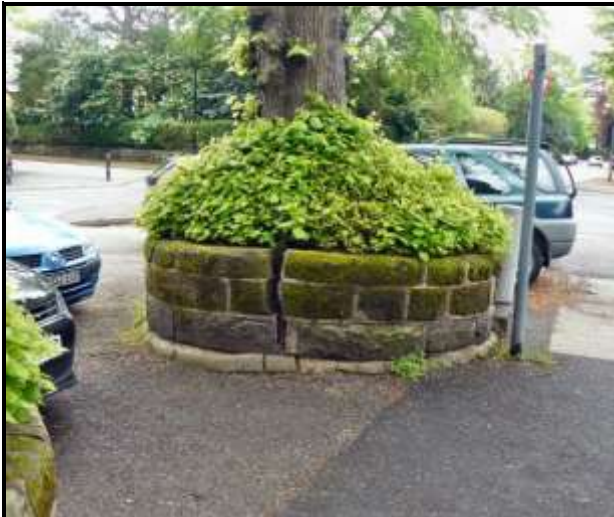
Photograph 117: Cracked Stone Planter, St Margaret's Road

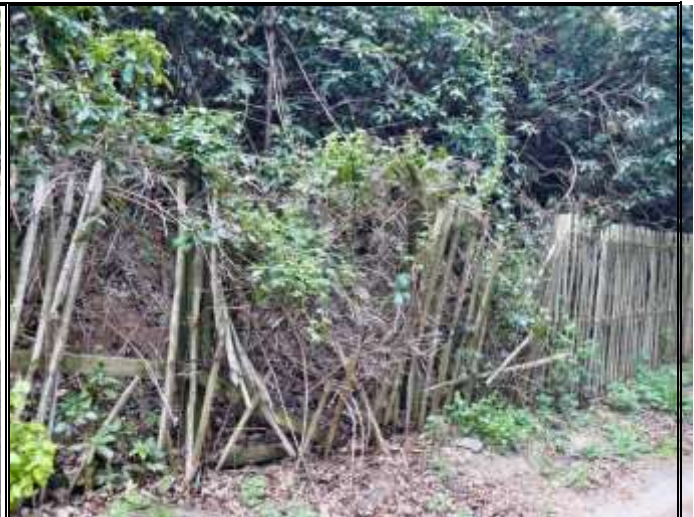
Photograph 118: Chestnut Paling on Dunham Road

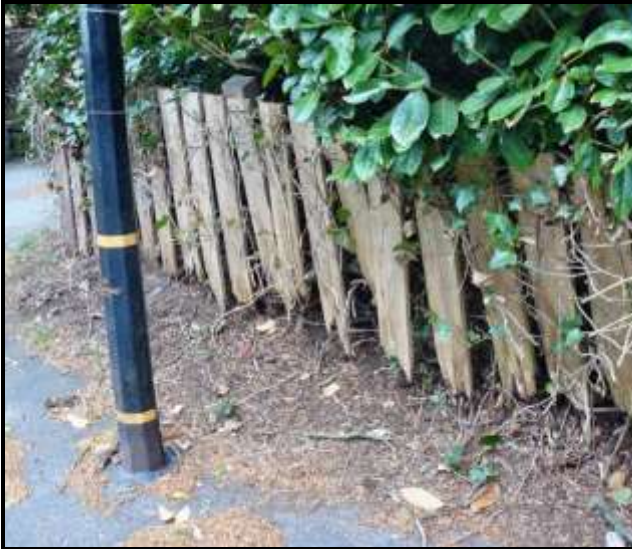
6.2.5 Due to the perishable nature of timber there are further examples of timber boundary treatments that are in need of repair, these include the timber panelled fencing along Charcoal Road (photograph 119) and Bradgate Road. Along Oldfield Road within the boundary extension there are areas where multiple forms of timber fencing have been used (photograph 120). This has a negative impact on the character of the Conservation Area.

Photograph 119: Timber Fence along Charcoal Road

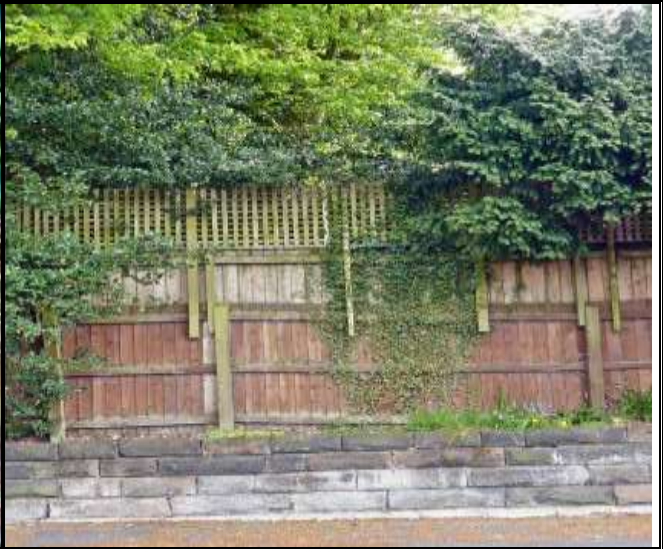
Photograph 120: Inappropriate Boundary Treatment along Oldfield Road

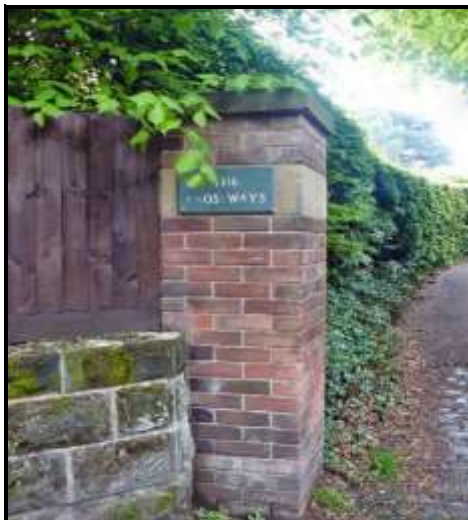
6.2.6 Loss of gateposts, painting of stone gateposts or their replacement with gateposts of inappropriate height or materials is harmful to the rhythm of the streetscape (photograph 121). There are examples of gate post completely painted and one example of a stone gate post that has had the house number spray painted on (photograph 122). Most houses only had one set of gates, so it is inappropriate in such cases to introduce a second opening. Many openings have been widened to accommodate cars over the last 100 years; it is important that the openings are not excessive and are framed by gateposts to retain the areas character. Wholesale loss of the boundary wall is detrimental to the wider area.

Photograph 121: Modern Replacement Gate Post, St Margaret's Road

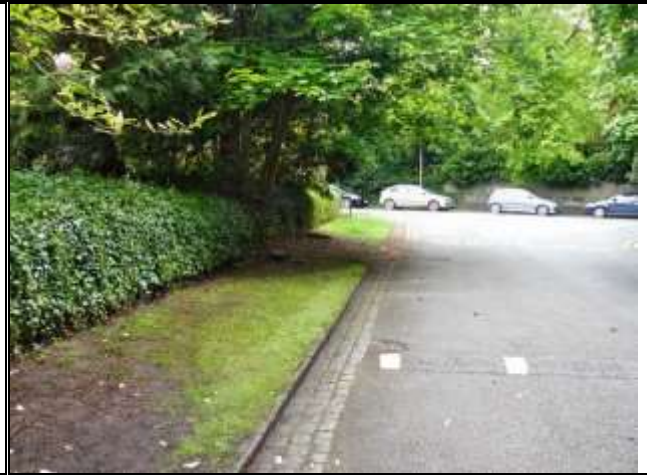
Photograph 124: Boundary Wall with Overgrown Ivy, Parkfield Road

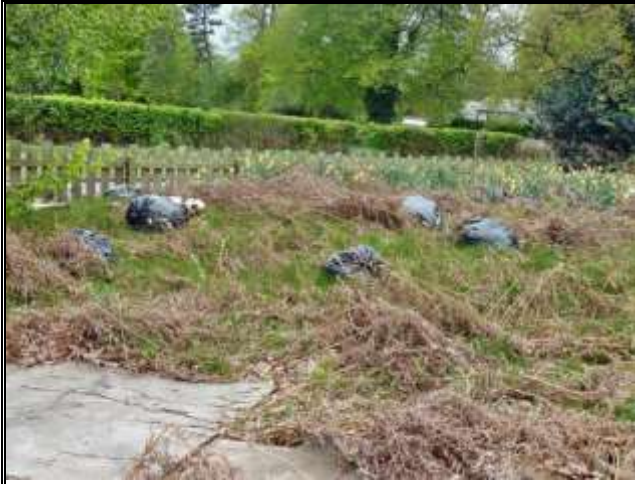
Photograph 125: Rubbish in the Front Garden of the Iranian Consulate

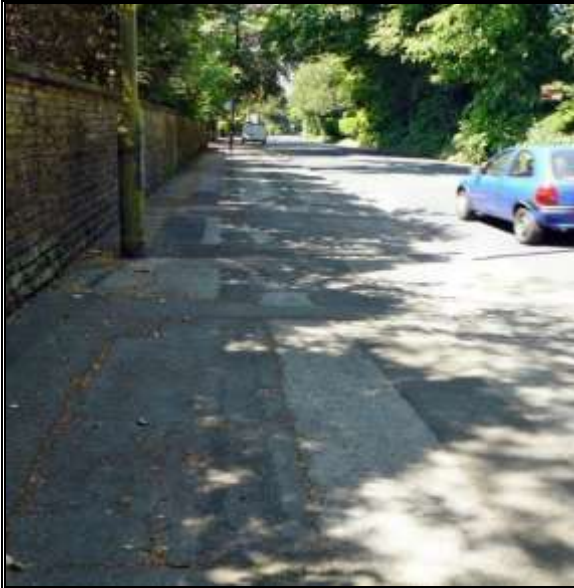
Photograph 127: Example of Patch Repairs, Park Road
