# **Dunham Town Conservation Area**

## **Conservation Area Appraisal October 2016**

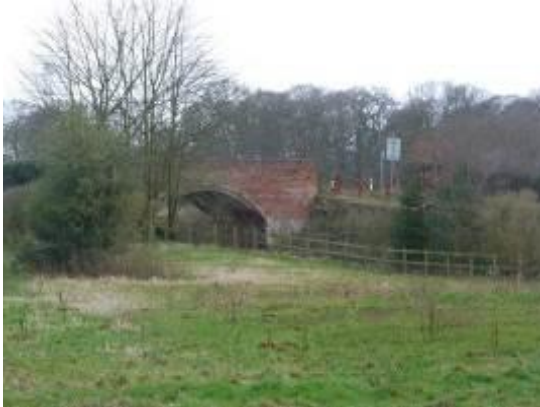
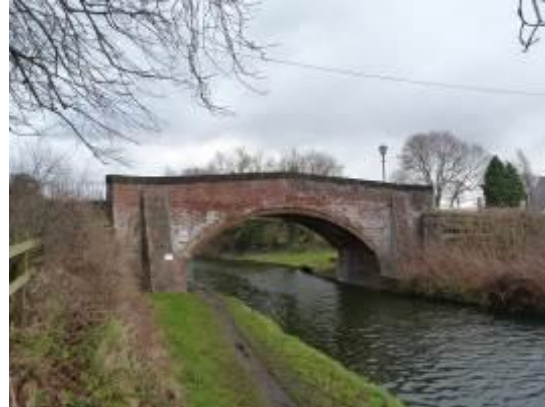
- 4.7.14 The two bridges in the north boundary extensions date from the late 18<sup>th</sup> century when the Bridgewater Canal was cut through the landscape. Dunham School Bridge spans over the canal at School Lane and Dunham Town Bridge crosses at Back Lane. They are simple but robust structures of a single large arch, constructed with brick with plain sandstone dressing.

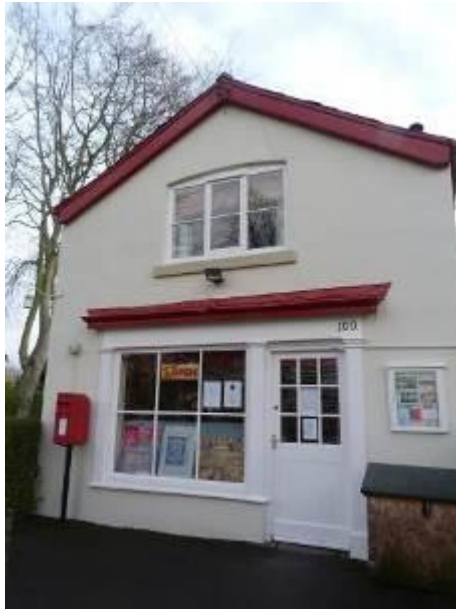
*Shop front, 100 School Lane*

- 4.7.26 There is a traditional village shop at 100 School Lane in the centre of the Conservation Area. Formerly a terrace of three cottages, a post office was established at the westernmost end of the terrace in the 19<sup>th</sup> century and the two remaining cottages were merged, resulting in today's arrangement. Alterations were evidently undertaken in the 19<sup>th</sup> century and the shop still retains its traditional large window adjacent to the entrance, both of which are set under a simple architrave.

- 6.2.9 The Post Office building on School Lane has brickwork elevations generally, with a rendered front façade. A vertical joint to the side elevations indicates that a shop unit was possibly added to the front of an older cottage. Incised ashlar joints to the render are taken round corners to form imitation quoins. There are timber casement windows. All elements appear in good condition, though there are some spalled bricks to the chimneys.

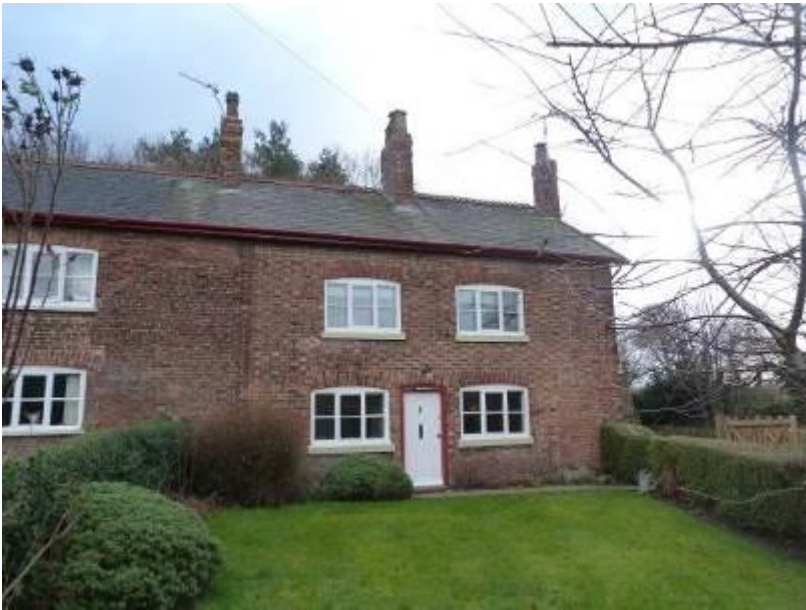
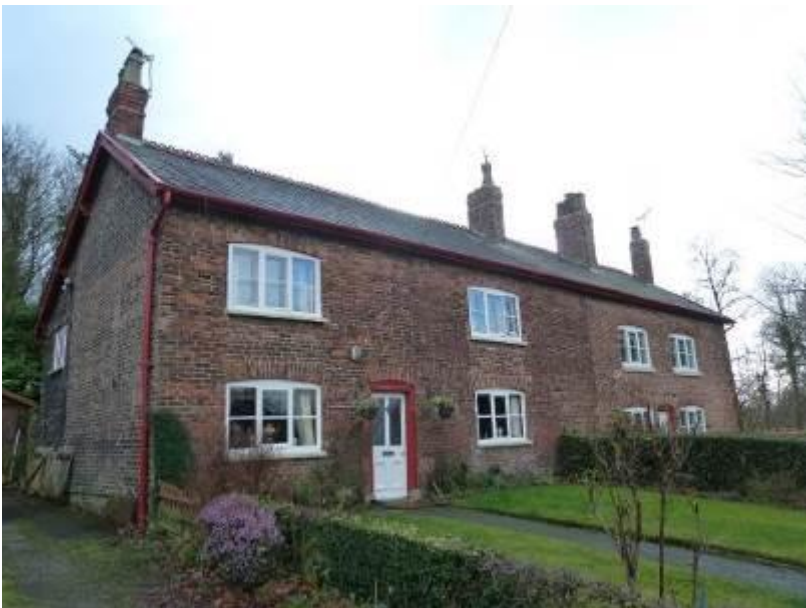
### Farm Cottage & Rose Cottage, Woodhouse Lane

Condition: Good

This terrace was formerly four cottages which have since been amalgamated into the remaining two. Scarring in the external brickwork indicates where changes have been made. The cottages are especially notable as examples of the brick workers' terraces prevalent both in Dunham Town and the wider Dunham Massey estate.

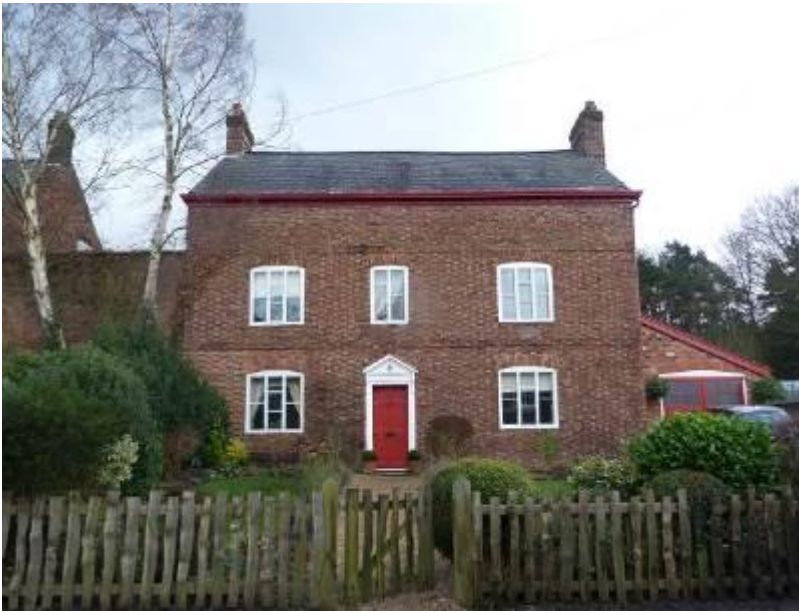
### Ivy House, Woodhouse Lane

Condition: Good

From the early 18<sup>th</sup> century through to the mid-19<sup>th</sup> century there was a flurry of building activity on the Dunham Massey estate, including a notable group of detached houses, of which Ivy House is one.<sup>25</sup> It is of a similar early 18<sup>th</sup>-century date as the northernmost Big Tree Cottages terrace. Its cambered brick lintels are repeated in the later Big Tree Cottages, indicating that the early 19<sup>th</sup> century builders copied the style opposite rather than the earlier cottages adjacent. The windows themselves have evidently been replaced and the asymmetrical style of the glazing bars is very unusual.

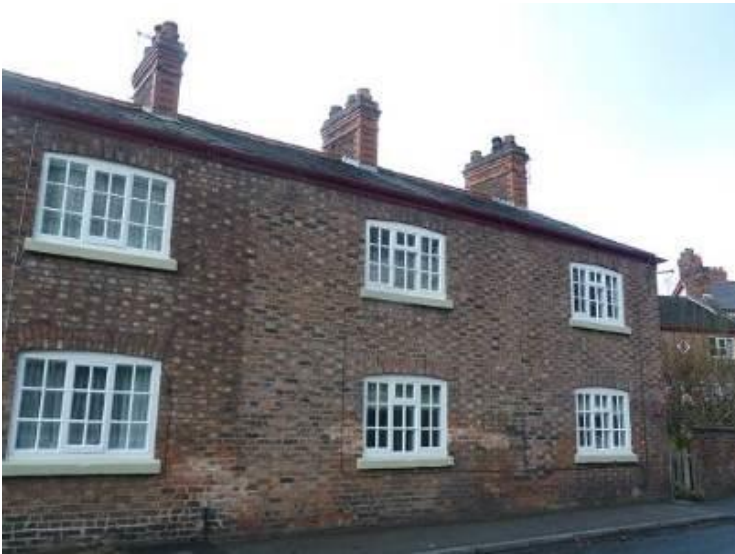
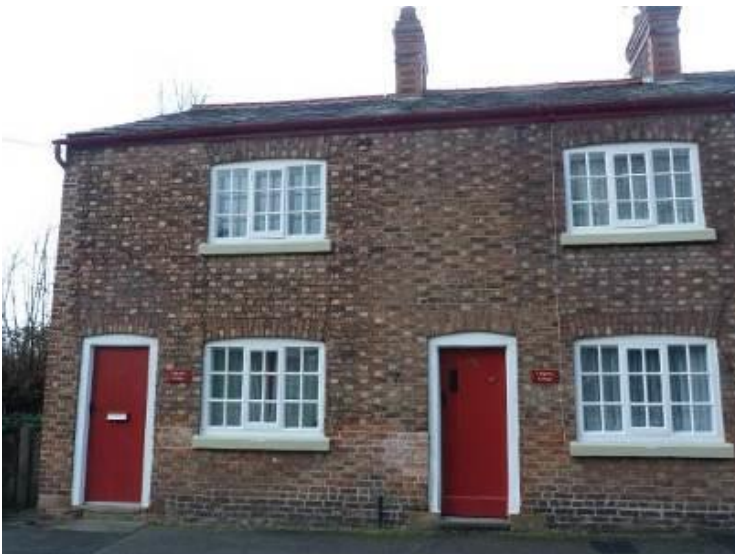
### 1, 3 and 4 Big Tree Cottages, Woodhouse Lane

Condition: Good

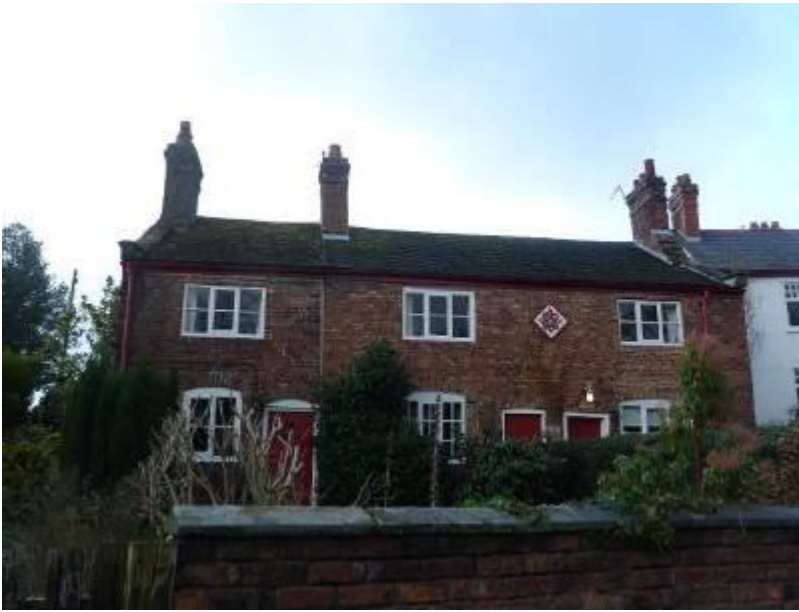
### Big Tree Cottages, Woodhouse Lane

Condition: Good

The second terrace of Big Tree Cottages is set further back from the road and has a date stone of 1730. As with their later neighbouring counterparts, the cottages are of brick with similar proportions but slightly different lintel styles. Both sets of Big Tree Cottages are notable examples of the modest workers' cottages prevalent throughout the wider Dunham Massey estate.

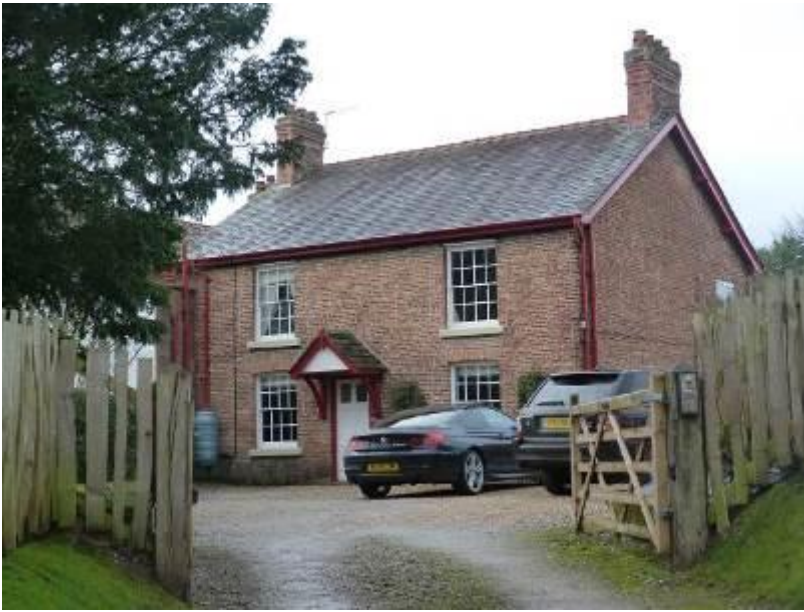
### Dog Farmhouse, School Lane

Condition: Good

Dog Farm House may potentially incorporate a smaller, earlier house. Scarring in the external brickwork indicates where alterations have historically taken place. The house is unusual for its large windows set high up under the eaves, more akin to the terraced cottages than other buildings of a similar size and age, such as Ivy House.

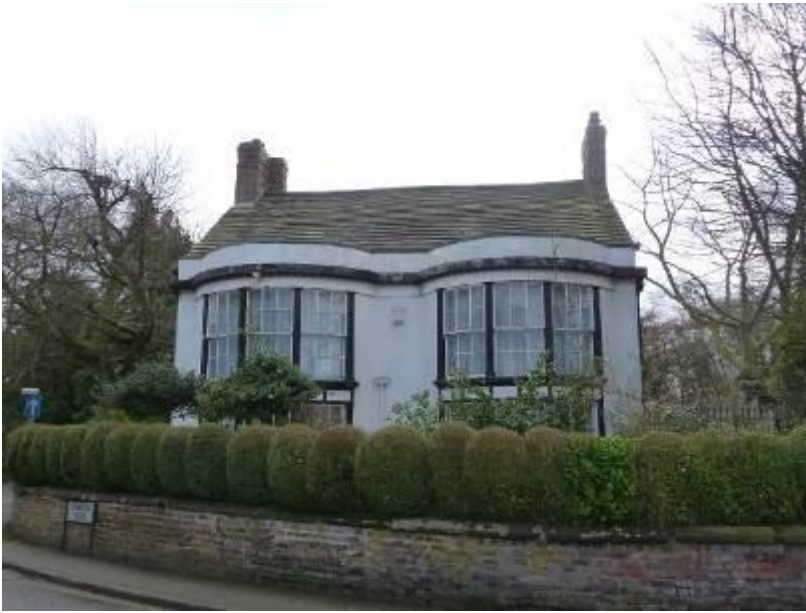
### **Big Tree House, Woodhouse Lane**

Condition: Good

Big Tree House is another of the detached buildings erected on the Dunham Massey estate. The two full-height semi-circular bays with their large windows are particularly notable features and are most likely early/mid-19<sup>th</sup>-century alterations.

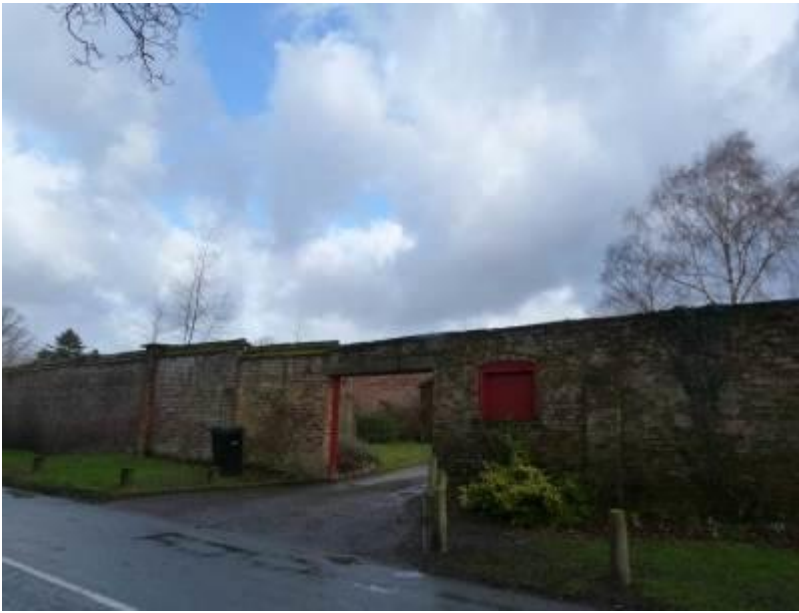
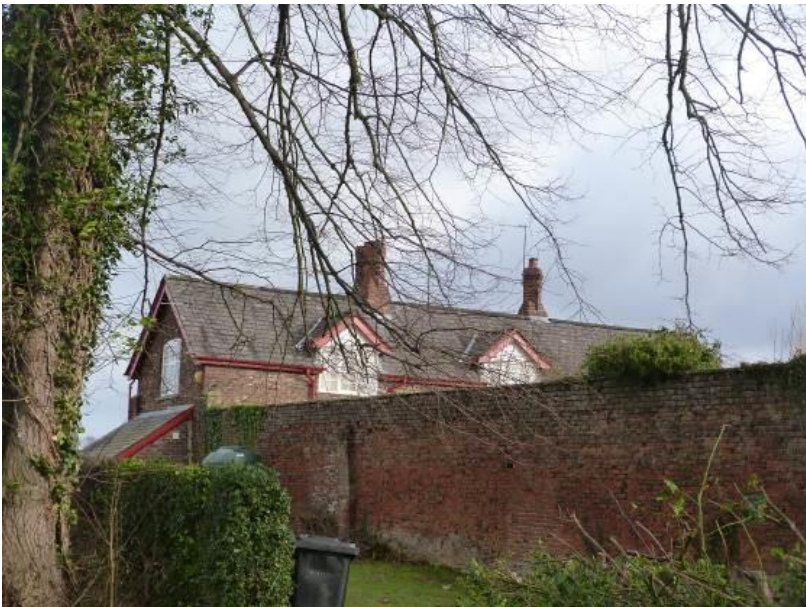
### **Kitchen Garden Wall & Gardener's Cottage, Smithy Lane**

Condition: Good

The kitchen garden is an important feature in the Conservation Area and is directly linked to the house at Dunham Massey. The wall brickwork is of good quality and the cottage is tucked away discreetly, with glimpsed views only of the upper levels. Unusually for the Conservation Area, the Gardener's Cottage has dormer windows.

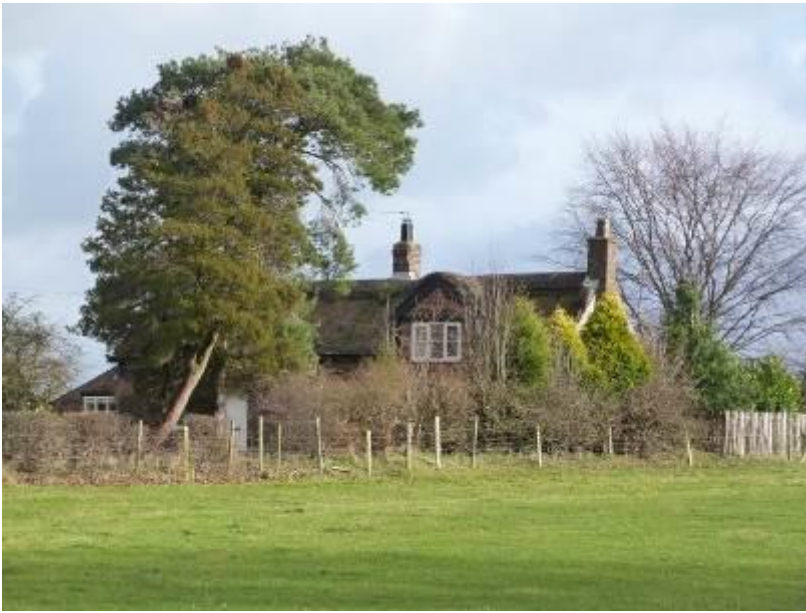
**Magnolia Cottage and The Meadows (Listed as ‘Magnolia the Meadows’), off School Lane**

Condition: Good

Magnolia Cottage and The Meadows are only partially visible from School Lane and accessed via a private access track. They are two of only a few thatched properties in the Conservation Area and are also notable for their age.

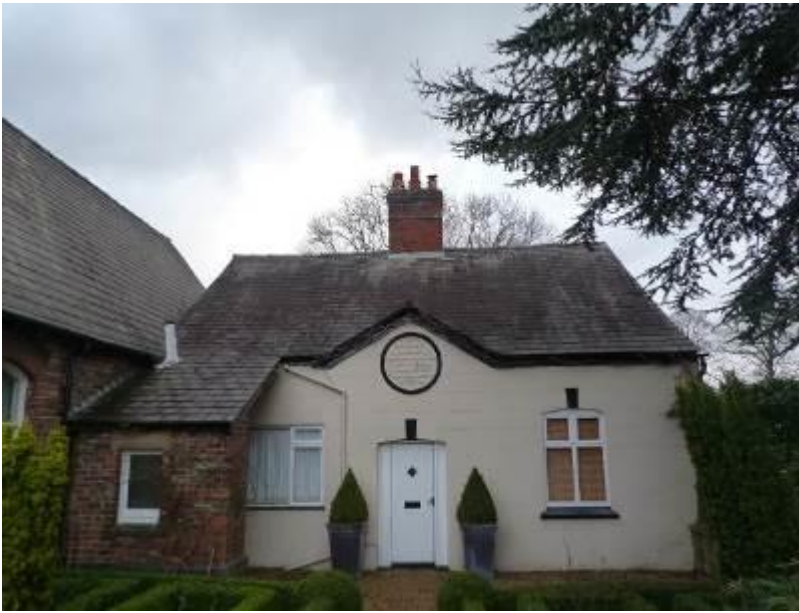
### Dunham School, School Lane

Condition: Good

Now a private residence with the parish hall attached, the former school was one of the original local amenities for villagers. Its original one-storey three-bay elevation is mostly visible and has a distinctive small pedimented gable over the door with a roundel plaque commemorating the foundation of the school by Thomas Walton in 1759.

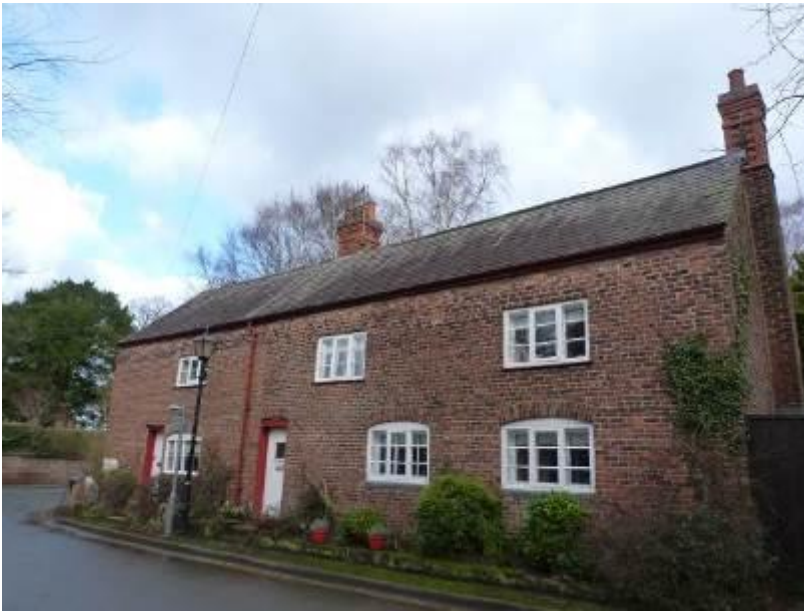
### Yew Tree Cottage and Lime Tree Cottage, Charcoal Road

Condition: Good

Although earlier in construction date, Lime Tree Cottage and Yew Tree Cottage at the corner of Woodhouse Lane and Charcoal Road have the same brick lintel style as the 1730s Big Tree Cottage terrace, indicating that alterations took place around that same time. It was originally one large house and has subsequently been divided into two cottages, which are notably larger than those on the opposite side of Woodhouse Lane.

- 6.2.11 On Charcoal Road the two storey terrace to the north is divided into two cottages: Lime Tree and Yew Tree. The brickwork to Yew Tree Cottage has been repointed in cement but the building is otherwise in good condition.

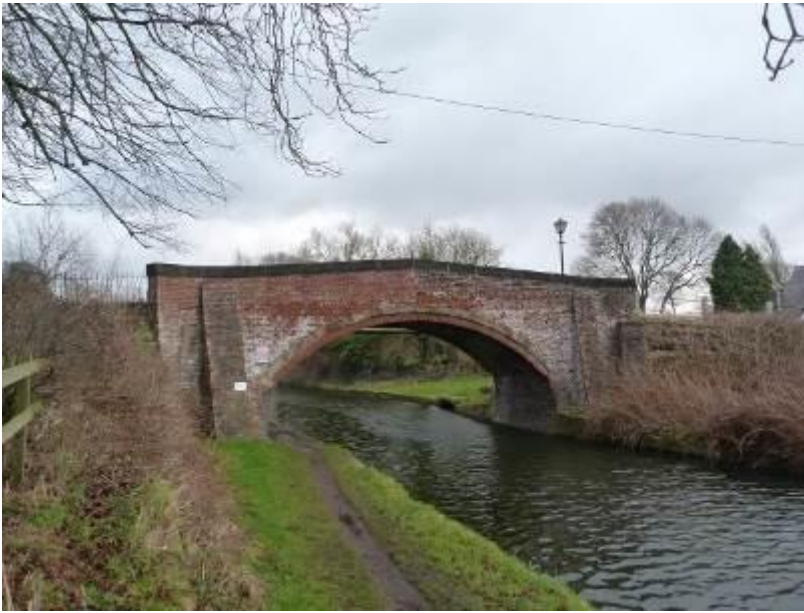
### **Dunham School Bridge, School Lane**

Condition: Good

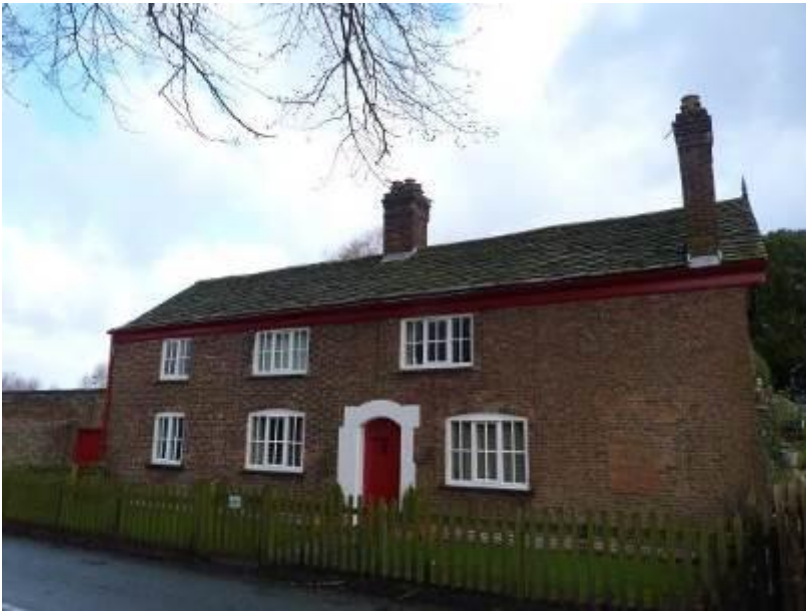
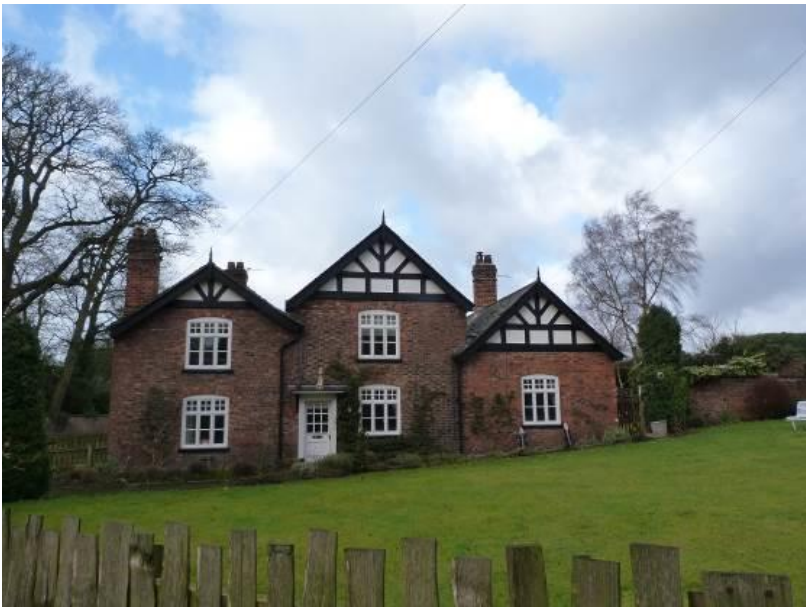
**101 Woodhouse Lane** (commonly known as Laundry Cottage)

Reason: Included for its contribution to the streetscape and interesting three-tier gable end. The windows have been replaced in a sympathetic, period-appropriate style, with different styles on the traditional street elevation and gabled side-elevation.

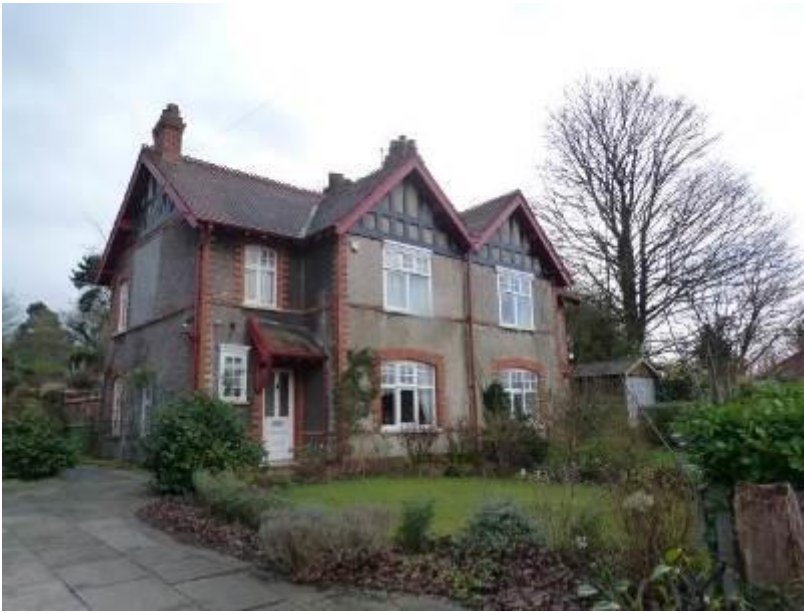
**Laurel Bank and Spinney Bank, Charcoal Road**

Condition: Good

Reason: Included for their contrasting architectural style which adds an additional layer of history to the Conservation Area. Also included as the site of a now-lost terrace of cottages evident in historic maps up until the early 20<sup>th</sup> century.

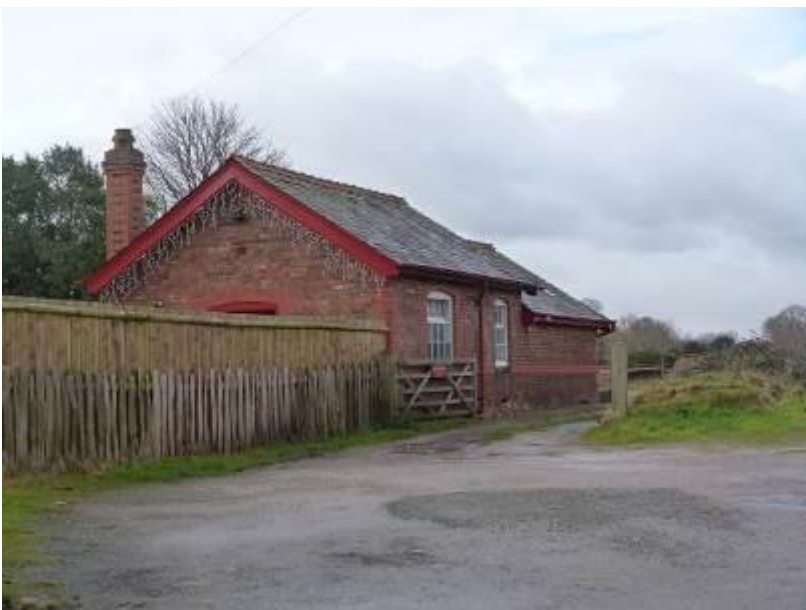
*Dog Farm outbuilding*

Date: Mid-19<sup>th</sup> and Early 20<sup>th</sup> Century

Condition: Good

- 6.3.6 In response to the evolving agricultural industry, the historic brick yard buildings both in Dunham Town and elsewhere in the wider Dunham Massey estate are commonly being re-appropriated for alternative use as a means of diversifying sources of income, for example the Lavender Barn at Dog Farm and the farm shop at Little Heath Farm. It is important that the historic agricultural buildings retain their traditional character and are not subjected to unsympathetic alteration.

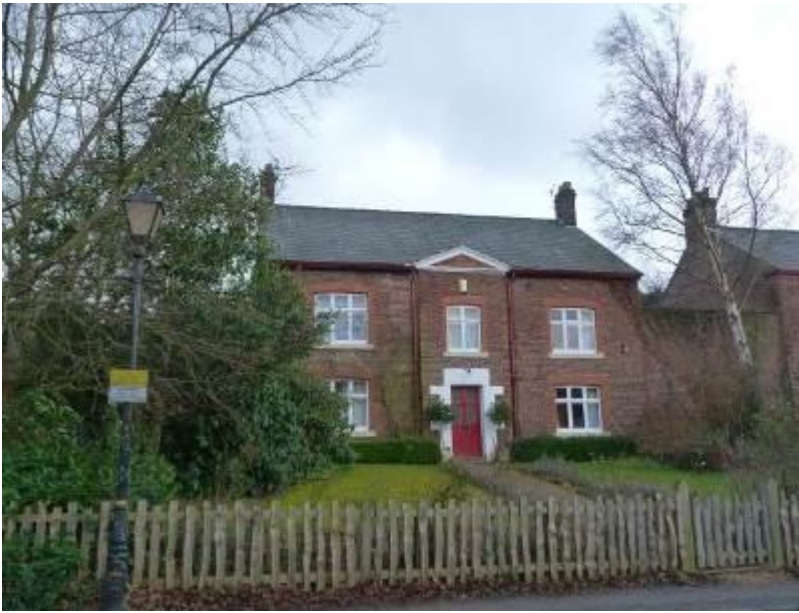
### The Red House, Woodhouse Lane

Reason: Included for historic value as an example of the detached houses built across the Dunham Massey estate in the 18<sup>th</sup> and 19<sup>th</sup> centuries. The smooth brick detailing around the windows is indicative of early 20<sup>th</sup>-century modification. The windows have evidently been replaced with modern alternatives which suit the dimensions of the window openings.

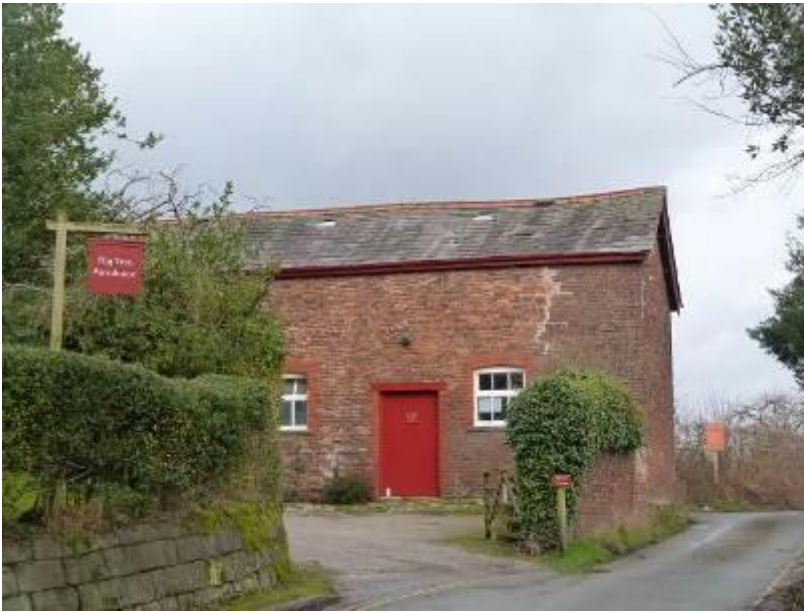
### Big Tree Farm, Charcoal Road

Date: Early 19<sup>th</sup> Century

Condition: Good

Reason: Included for historic value as a farmstead has been evident on this site since at least the late 18<sup>th</sup> century. The house itself is not visible from the public thoroughfare. The outbuilding is included for its traditional agricultural aesthetics and as another example where early 20<sup>th</sup>-century alterations have been made. The building to the rear, currently housing the Dunham Massey Brewing Company, is also included in this entry.

- 6.2.12 Big Tree Farm house and barn are set at right angles to each other. The mortar to the barn has been eroded and requires repointing generally but the buildings are otherwise in reasonable condition.

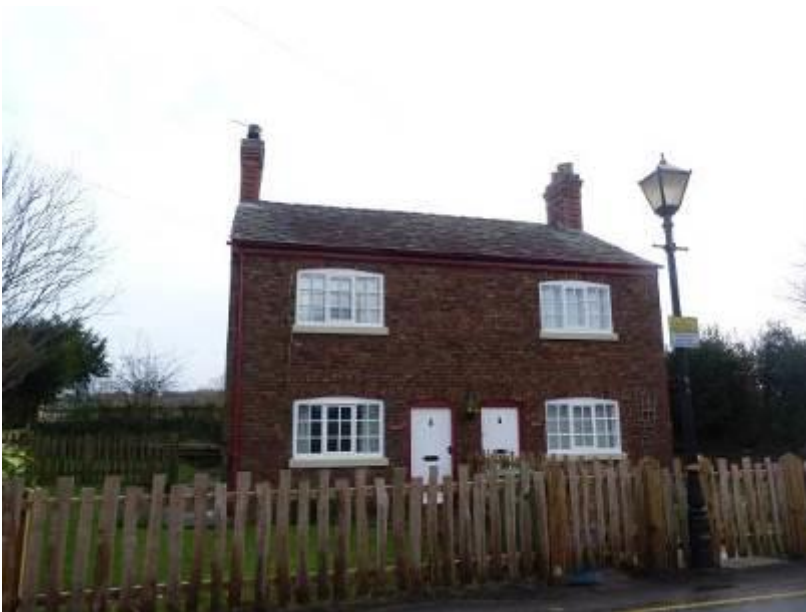
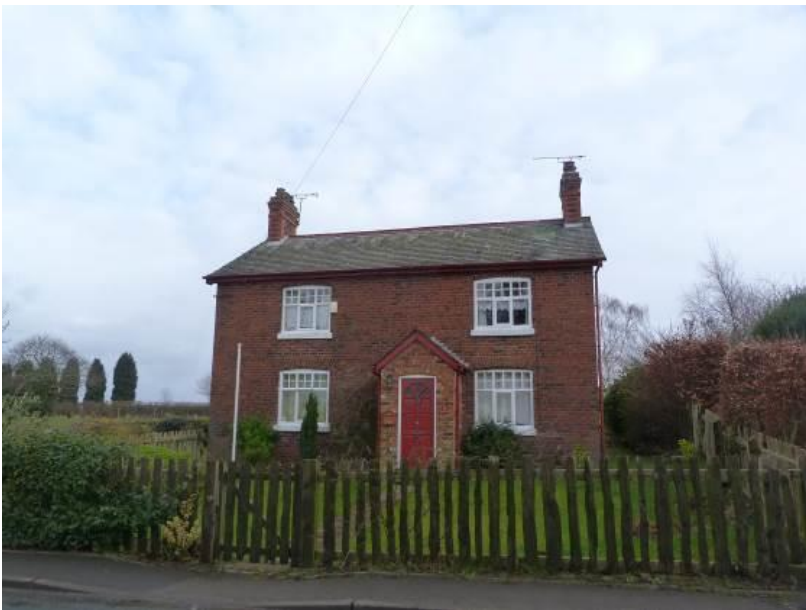
## Red Brick School Lane Cottages: West View, Sunset View, Rose Cottage, Harthill Cottage and The Homestead

*West View and Sunset View*

*The Homestead*

Date: 19<sup>th</sup> Century

Condition: Good

Reason: Included as typical examples of modest workers' cottages and sympathetic replacement windows. Particularly notable for group value. The Smithy is also notable for the historic smithy attached to the rear which, given its style, is likely to have been re-built in the early 20<sup>th</sup> century but is evident in earlier maps.

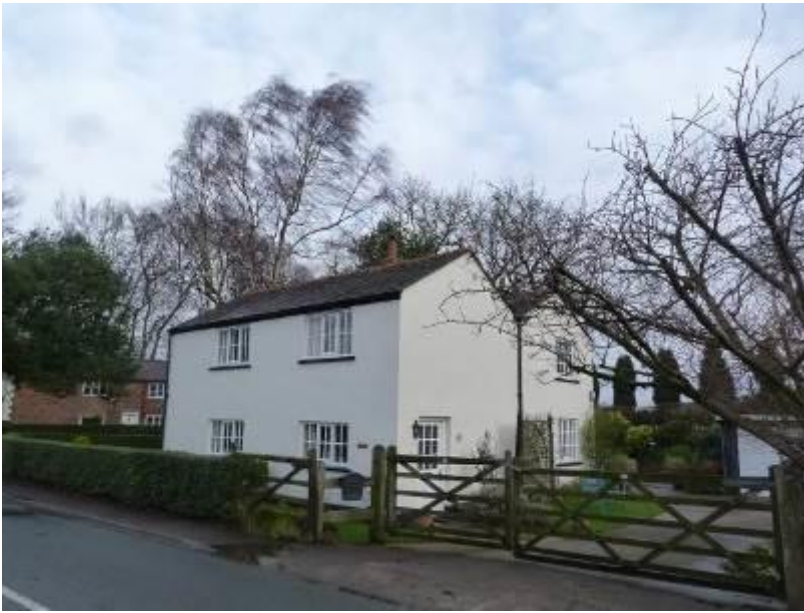
### **The Willows, School Lane**

Date: Mid-19<sup>th</sup> Century

Condition: Good

Reason: Included for positive contribution to streetscape and distinctive double-pitched roof.

- 6.2.10 The Willows has walls rendered with incised joints and timber casement windows. All elements appear well maintained and in good condition. The collection of four detached buildings to the south are all well maintained and in good condition.

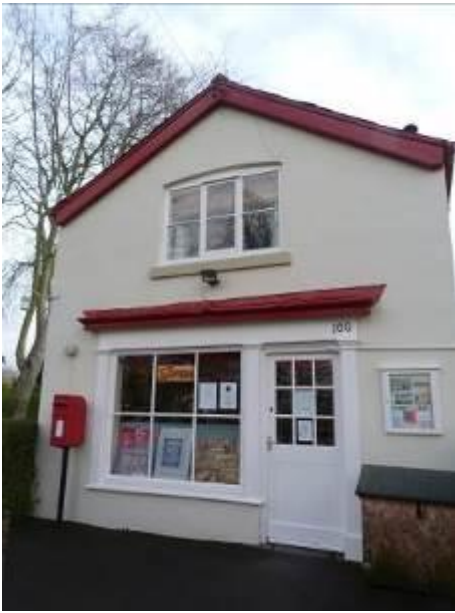
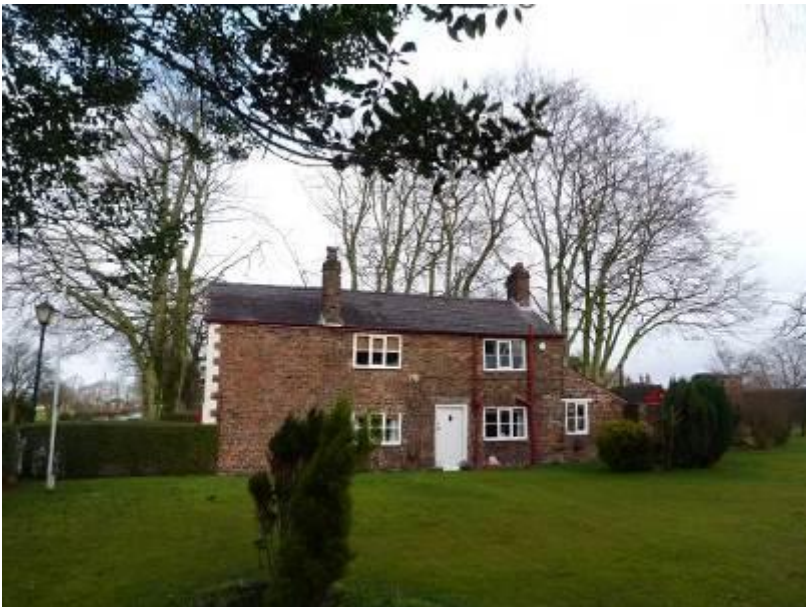
### 100 School Lane (shop)

*Shop front, 100 School Lane*

*South elevation of 100 School Lane*

Date: Early 19<sup>th</sup> Century

Condition: Good

Reason: Included as a surviving historic local amenity with a simple traditional shop window. The cottage adjoining exhibits the same simple detailing and modest proportions extant throughout the Conservation Area.

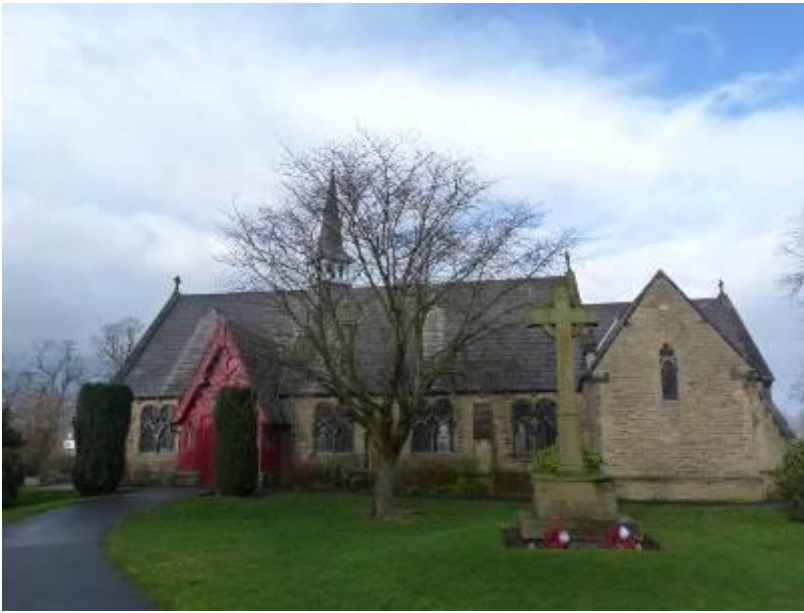
**St Mark's Church, junction of School Lane and Back Lane**

Date: Mid-19<sup>th</sup> Century

Condition: Good

Reason: The church is a focal point in the centre of the Conservation Area which has seen little change and has high communal value.

- 6.2.6 St Marks Church is generally well maintained. There is evidence of a recent repair to a stepped crack on the west gable below window. The extension to the north of the church is of a suitable scale and style.

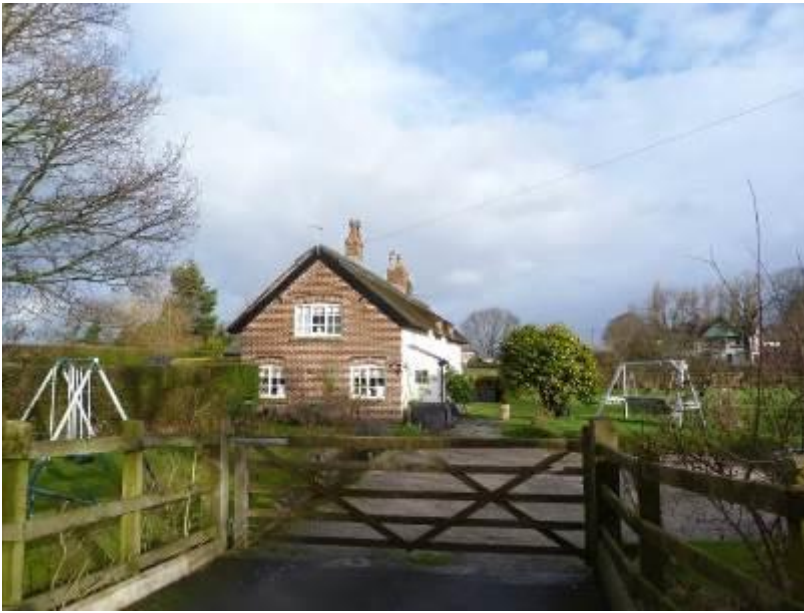
### **Fir Tree Cottages, Back Lane**

Date: Early 19<sup>th</sup> Century

Condition: Good

Reason: Included as examples of traditional modest cottages which are notable for their retention of a traditionally rural thatched roof.

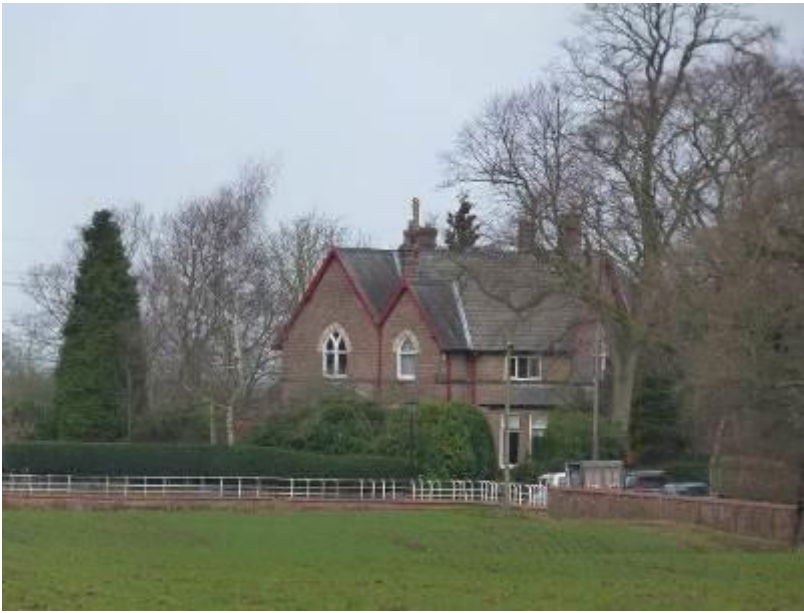
### **Bishop's Lodge, Back Lane**

Date: Mid-19<sup>th</sup> Century

Condition: Good

Reason: Bishop's Lodge is only partially visible from the public thoroughfare. It is included for its historical value and contrasting early Victorian architectural style.

- 6.2.8 Bishop's Lodge is set back from the road and partially obscured. The windows have been replaced but otherwise the building appears in good condition. Lime Tree House appears to have been recently renovated and is in good condition. Hemp Field is set back slightly from the road. Where visible the brickwork walls have been painted or rendered with a rough cast. The building appears well maintained but a damp patch was noted to the render at a parapet gutter outlet.

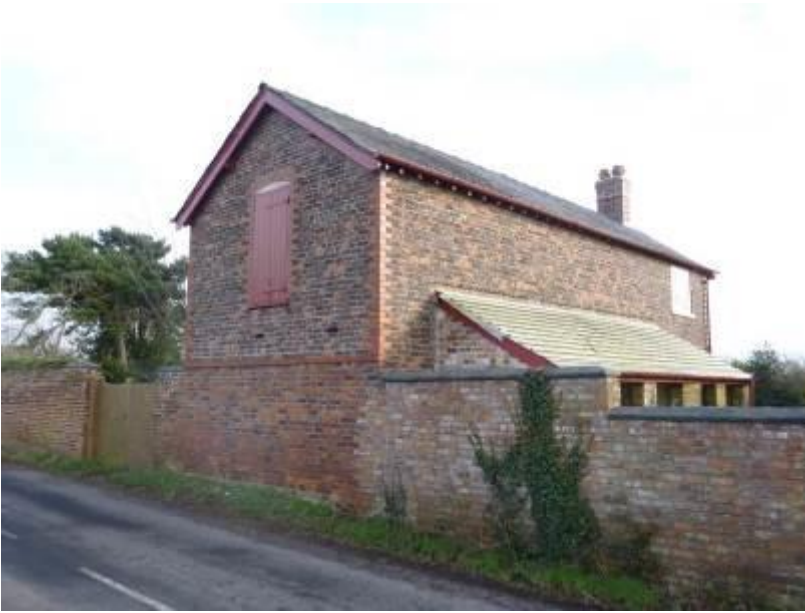
**The Old Blacksmith's, Back Lane (commonly known as Hempfield Stables)**

Date: Early 19<sup>th</sup> Century (possibly with later rebuilding)

Condition: Good

Reason: Included for its historic value as the site of the village blacksmith with nearby pond to provide cooling water. It has been sympathetically restored in recent years and retains its traditional small windows with casements to the upper third.

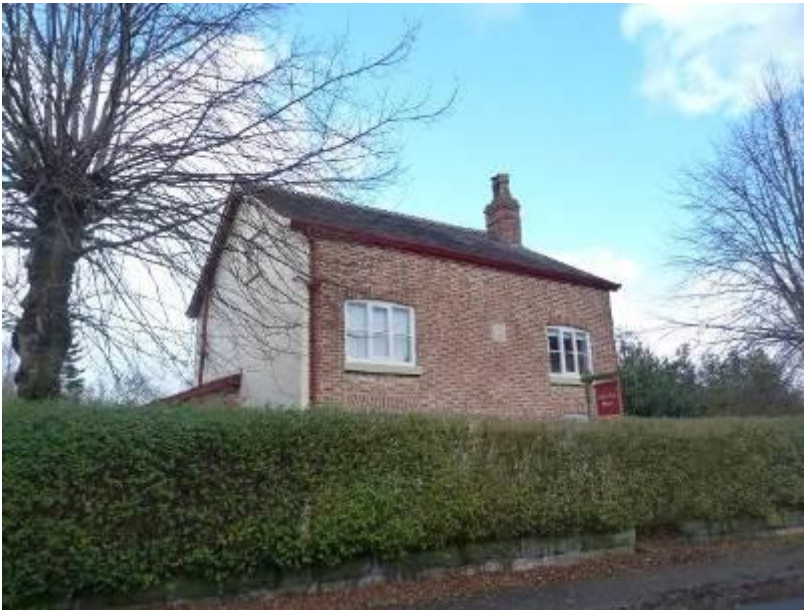
**Lime Tree House, Back Lane**

Date: Early 19<sup>th</sup> Century

Condition: Good

Reason: Included as an example of one of the smaller detached houses built on the Dunham Massey estate between the 18<sup>th</sup> and 19<sup>th</sup> centuries.

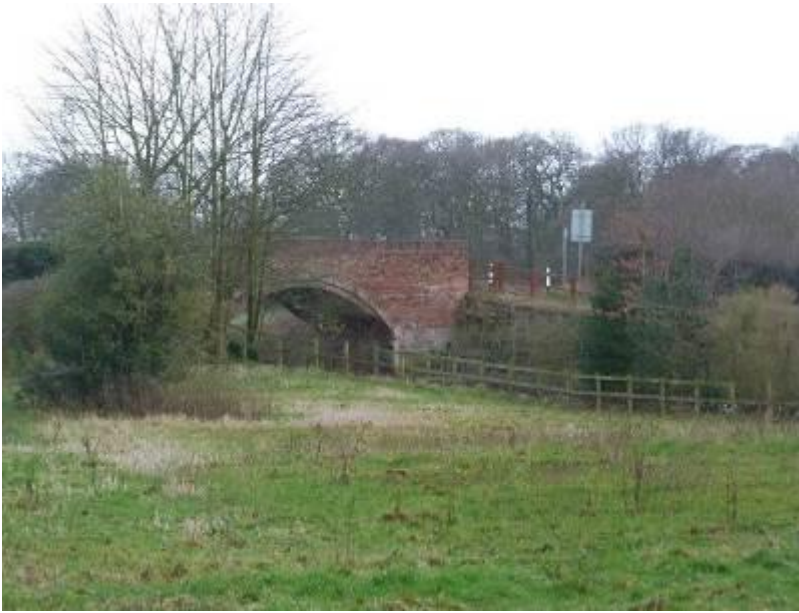
### **Dunham Town Bridge, Back Lane**

Date: 1770s

Condition: Good

Reason: Included for group value with Dunham School Bridge and their collective historic association with the 1776 Bridgewater Canal (for clarification this includes the boundary walls either side).

- 6.2.21 To the north, the majority of the brickwork of the canal bridge on School Lane has been poorly repointed in cementitious mortar applied over the brick arises. There are also some areas of eroded pointing to the external face of the bridge. Large sections of the balustrade wall have been rebuilt in poorly matched brick. Multiple copings are damaged, which appears to be from vehicle collisions, and some copings have been replaced. The stone string course has been heavily eroded and the stone retaining walls to pedestrian ramps are covered by vegetation. The railings beyond the bridge to the north are in poor condition, require decorating and several sections have buckled. There is graffiti to the brickwork at canal level. There are concerns that large vehicles are damaging the bridges, particularly Back Lane.

- 6.2.22 To the north of Back Lane, large areas of the brickwork to the canal bridge has spalled to both sides of bridge, due to hard pointing. There are some areas of eroded pointing to the external face. The concrete copings have eroded and lost their finished face in several areas. The stone retaining walls to the pedestrian ramps are covered by vegetation, as is the stone canal edge to the south bank. The railings beyond the bridge to the north are in poor condition, require decorating and several sections have buckled. There is graffiti to the brickwork at canal level.

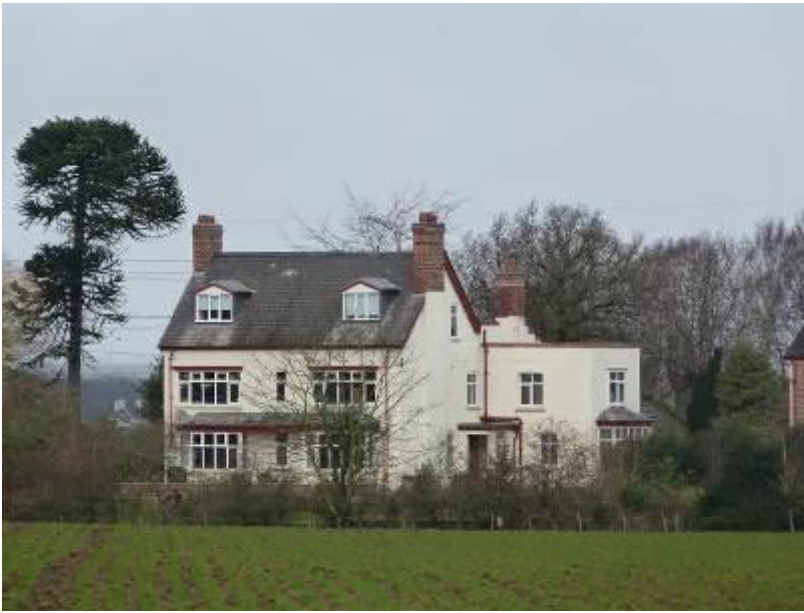
## Hempfield, Back Lane

Date: Early 19<sup>th</sup> Century (possibly with later rebuilding or substantial remodelling)

Condition: Good

Reason: Included for its good-quality early 20<sup>th</sup>-century architecture and positive contribution to views across the field from School Lane.

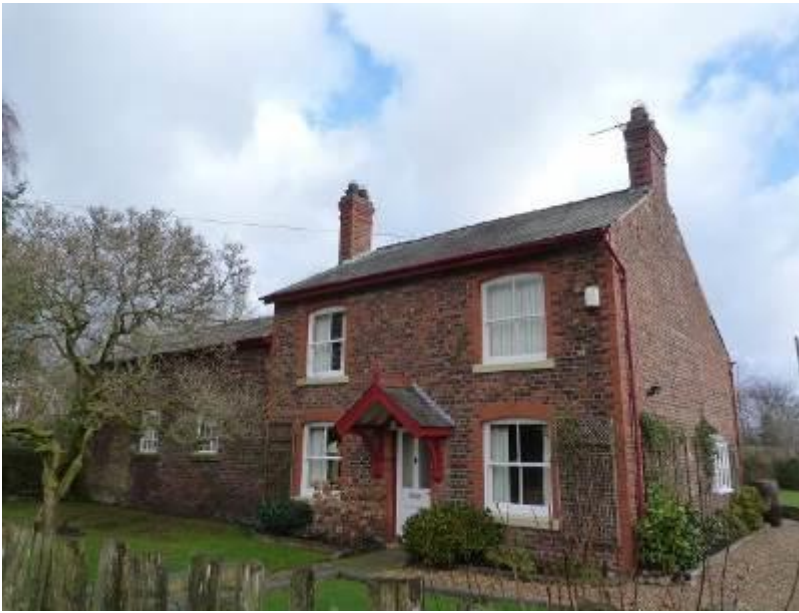
**Grosvenor Cottage, School Lane**

Date: 19<sup>th</sup> Century (with 20<sup>th</sup>-century alterations to the exterior)

Condition: Good

Reason: Typical of the local estate workers' cottages and included for group value with other cottages further south on School Lane.

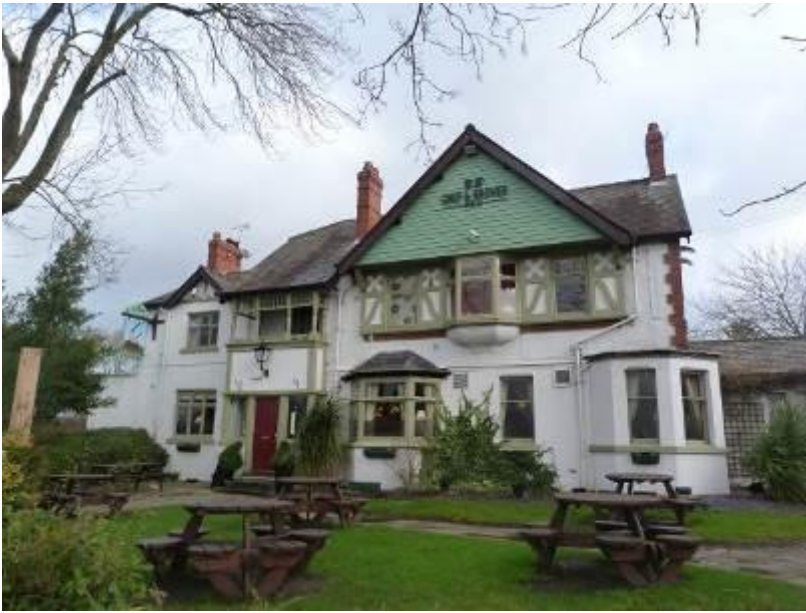
**Axe & Cleaver, School Lane**

Date: Late 19<sup>th</sup> Century (with modern external refurbishment)

Condition: Good

Reason: Included as a historic local amenity with high communal value and contrasting Victorian architectural style.

6.2.2 The Axe and Cleaver public house has some sections of timber frame visible, presumably decorative. There is horizontal boarding to the dormer gable, possibly covering deteriorated timber framing behind. The out-buildings to the rear are in poor condition with some slates and ridge tiles missing. The end section appears to be derelict with windows missing and vegetation growing in.

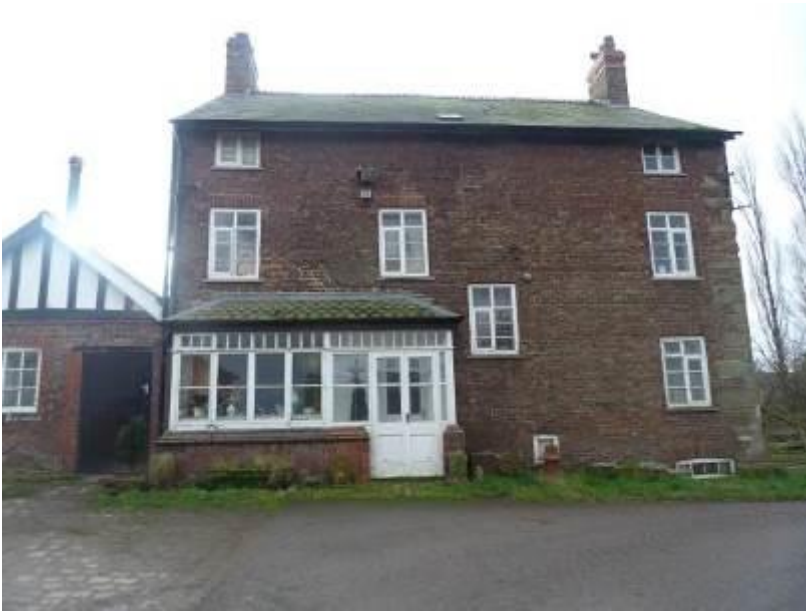
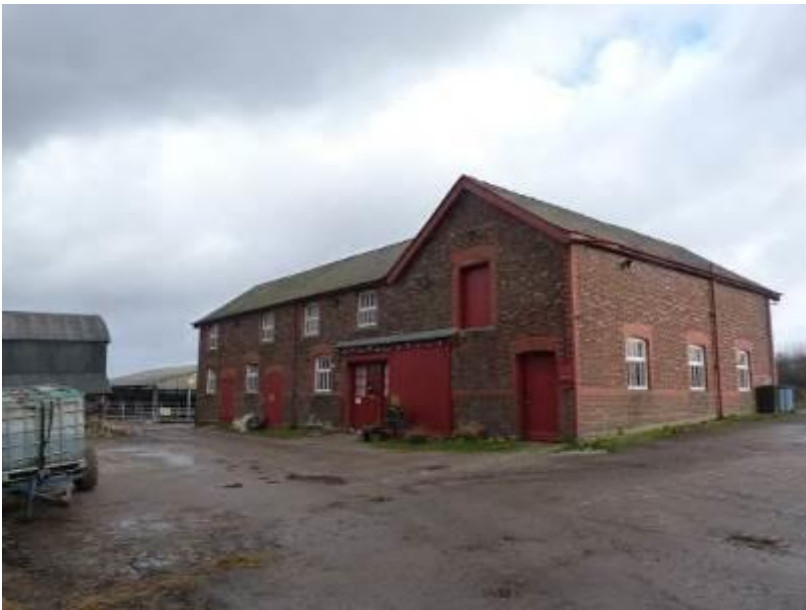
### Little Heath Farm, off School Lane

*Heath Farm House*

*Little Heath Farm Yard*

Date: 18<sup>th</sup>-20<sup>th</sup> Century

Condition: Good

Reason: Included collectively for group and historic value. A farmstead has been present here since the 18<sup>th</sup> century, from which time the house is believed to date, and there is evidence of early 20<sup>th</sup>-century rebuilding as part of the estate-wide improvements to agricultural buildings.

6.2.3 Heath Farm has been poorly repointed with a cementitious mortar applied over the brickwork. Windows have been replaced with modern casements. Spalled brickwork was noted to the associated outbuilding.

- 6.2.5 Little Heath Farm is a collection of buildings set back to the east of School Lane. The main Farm House is of brickwork walls in English Garden Wall bond and has slate roofs. There are stone quoins to the west gable and delamination was noted to several. The brickwork is in fair condition, though some areas of pointing have been eroded. The timber casement windows are in reasonable order. The associated two agricultural buildings are in reasonable order generally, though patch pointing is required and one section of gutter is missing. Little Heath Cottages were only partially visible from the road but appeared in good condition other than slipped slates to the roof.

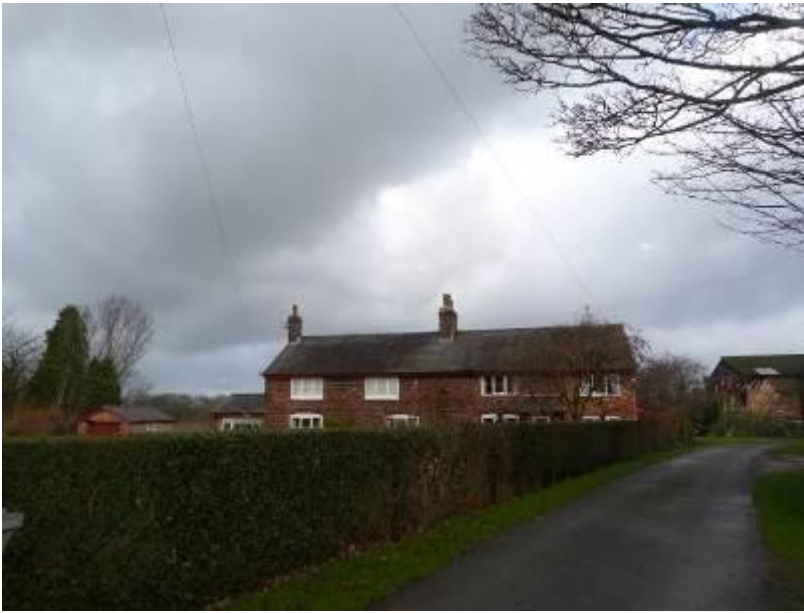
### Little Heath Cottages, off School Lane

Date: Mid-19<sup>th</sup> Century

Condition: Good
