# **Dunham Town Conservation Area**

## **Conservation Area Appraisal October 2016**

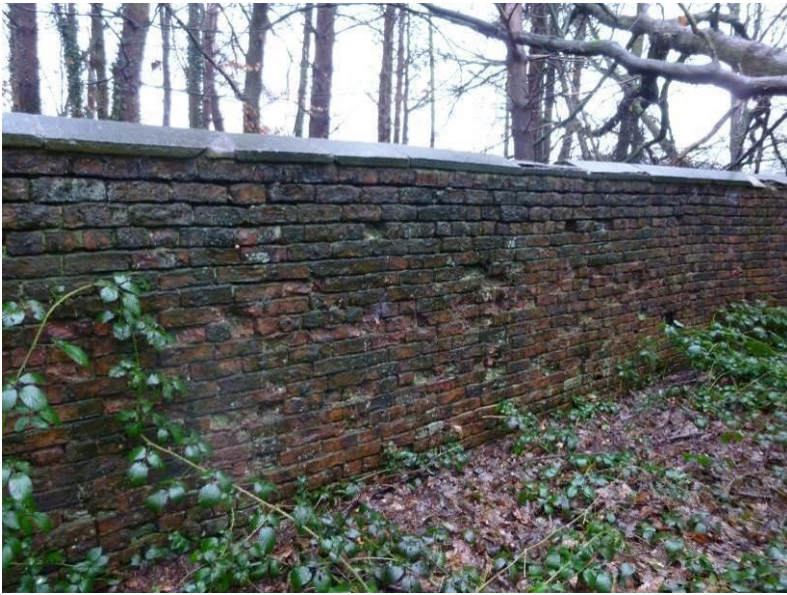
Condition: Good to Poor

Reason: Included for historic value as a feature of the Dunham Massey estate landscape and aesthetic value as a good quality brick wall. The poor condition mars its appearance in places.

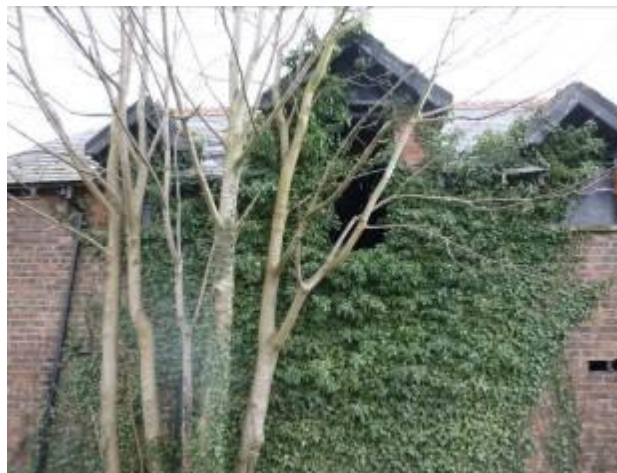
6.2.2 The Axe and Cleaver public house has some sections of timber frame visible, presumably decorative. There is horizontal boarding to the dormer gable, possibly covering deteriorated timber framing behind. The out-buildings to the rear are in poor condition with some slates and ridge tiles missing. The end section appears to be derelict with windows missing and vegetation growing in.

*Derelict outbuilding to Axe and Cleaver*

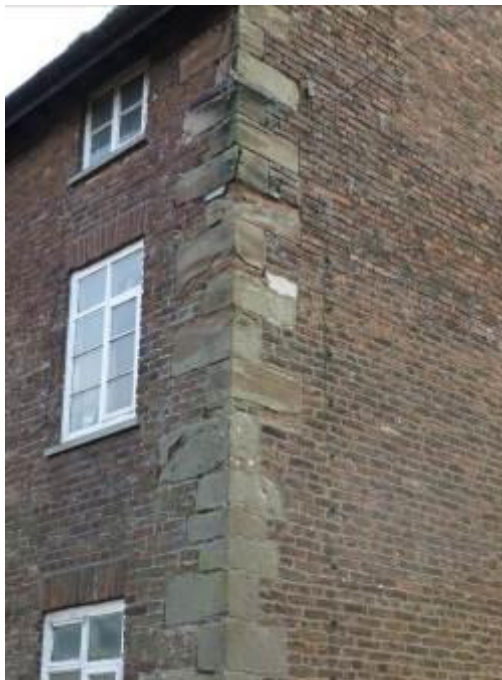
- 6.2.5 Little Heath Farm is a collection of buildings set back to the east of School Lane. The main Farm House is of brickwork walls in English Garden Wall bond and has slate roofs. There are stone quoins to the west gable and delamination was noted to several. The brickwork is in fair condition, though some areas of pointing have been eroded. The timber casement windows are in reasonable order. The associated two agricultural buildings are in reasonable order generally, though patch pointing is required and one section of gutter is missing. Little Heath Cottages were only partially visible from the road but appeared in good condition other than slipped slates to the roof.

*Eroded Quoins to Little Heath Farm House*

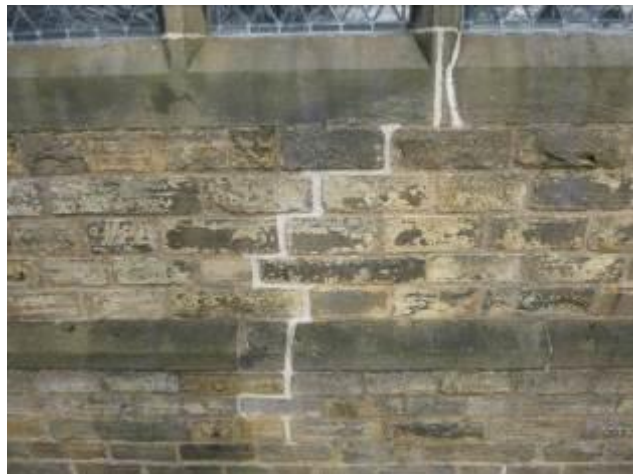
- 6.2.6 St Marks Church is generally well maintained. There is evidence of a recent repair to a stepped crack on the west gable below window. The extension to the north of the church is of a suitable scale and style.

*Repaired stepped crack to St. Mark's Church*

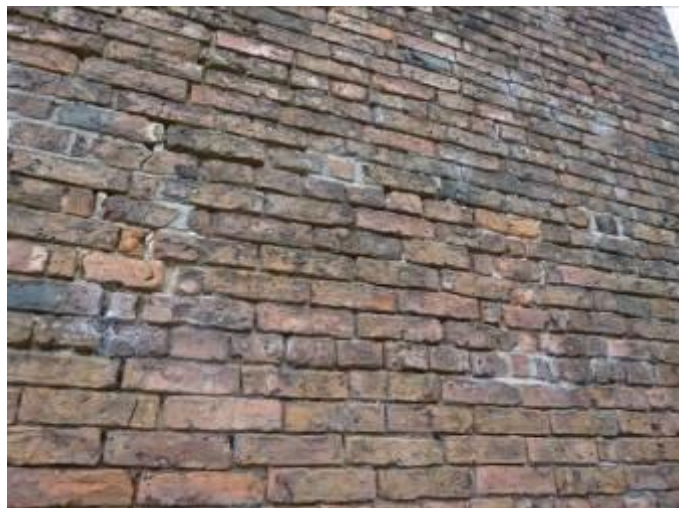
- 6.2.12 Big Tree Farm house and barn are set at right angles to each other. The mortar to the barn has been eroded and requires repointing generally but the buildings are otherwise in reasonable condition.

*Eroded pointing to the barn at Big Tree Farm*

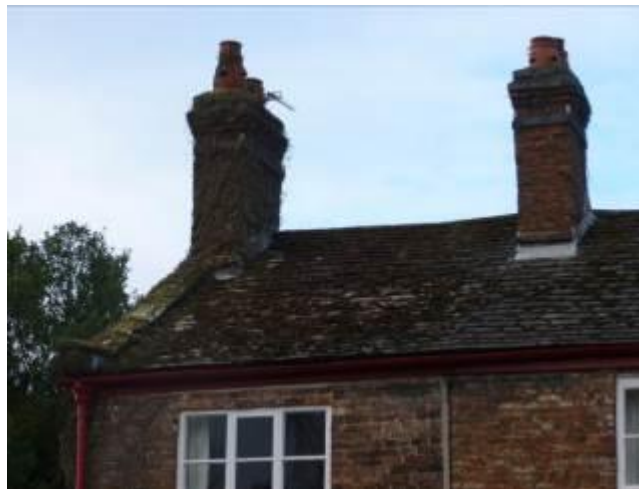
*Moss and vegetation to the roof of Big Tree Cottages*

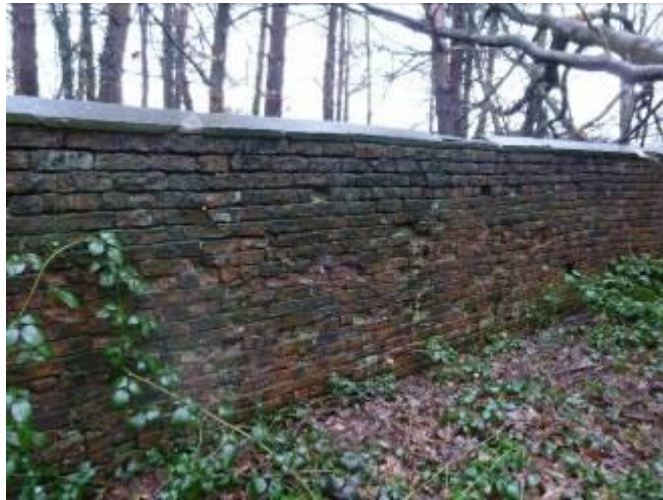
- 6.2.20 Between Smithy Lane, Charcoal Road and School Lane, the section of redundant Dunham Massey estate wall is in poor condition with various areas of spalled brickwork, eroded pointing, delaminated copings, loose, missing or poorly repaired copings, undermining from animals, vegetation, moss and algal growths to brickwork. A lean-to structure to the rear has a roof flashed onto copings and an overflow pipe passing through the wall causing localised erosion.

*Section of estate wall with eroded pointing, spalled bricks and damaged copings*

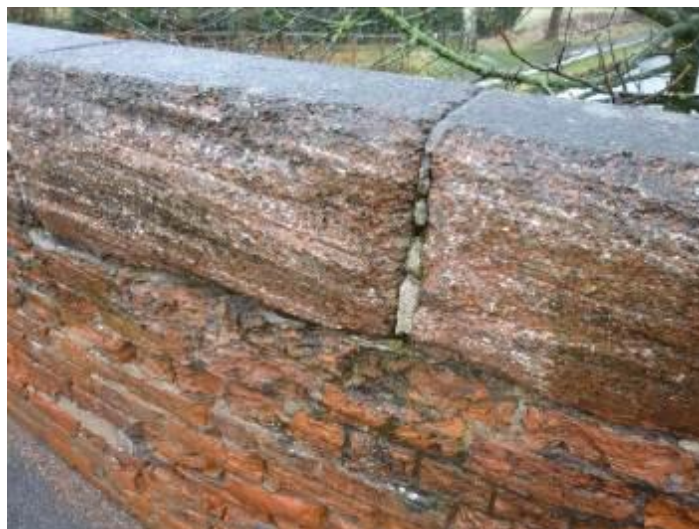
- 6.2.22 To the north of Back Lane, large areas of the brickwork to the canal bridge has spalled to both sides of bridge, due to hard pointing. There are some areas of eroded pointing to the external face. The concrete copings have eroded and lost their finished face in several areas. The stone retaining walls to the pedestrian ramps are covered by vegetation, as is the stone canal edge to the south bank. The railings beyond the bridge to the north are in poor condition, require decorating and several sections have buckled. There is graffiti to the brickwork at canal level.

*Eroded concrete copings and spalled brickwork below*

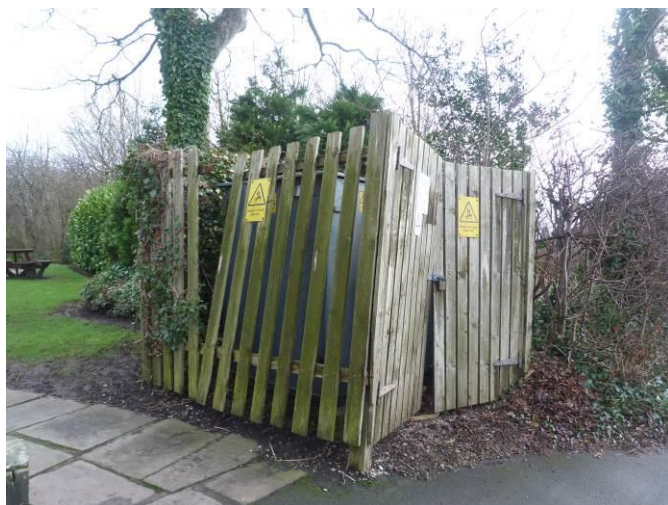
*Sub-station near Axe and Cleaver*

- 6.3.8 A modern sub-station near the Axe and Cleaver is poorly disguised and consequently has a negative impact on the aesthetics of the streetscape. Likewise, there are adjacent modern piers supporting an elevated pipeline against the east side of Dunham School Bridge which completely obscures this elevation from view and is a significantly detracting feature.

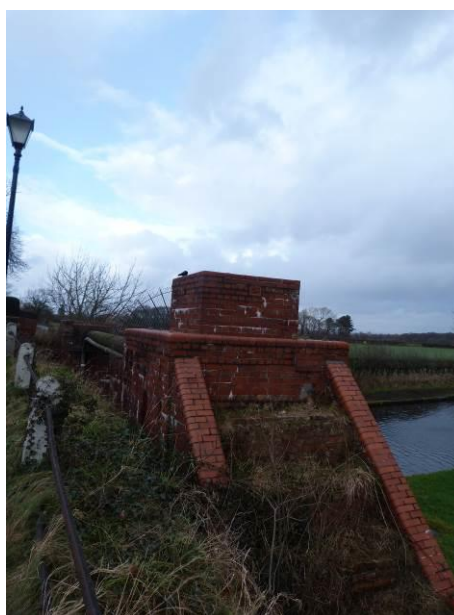
*Elevated pipeline by Dunham School Bridge*

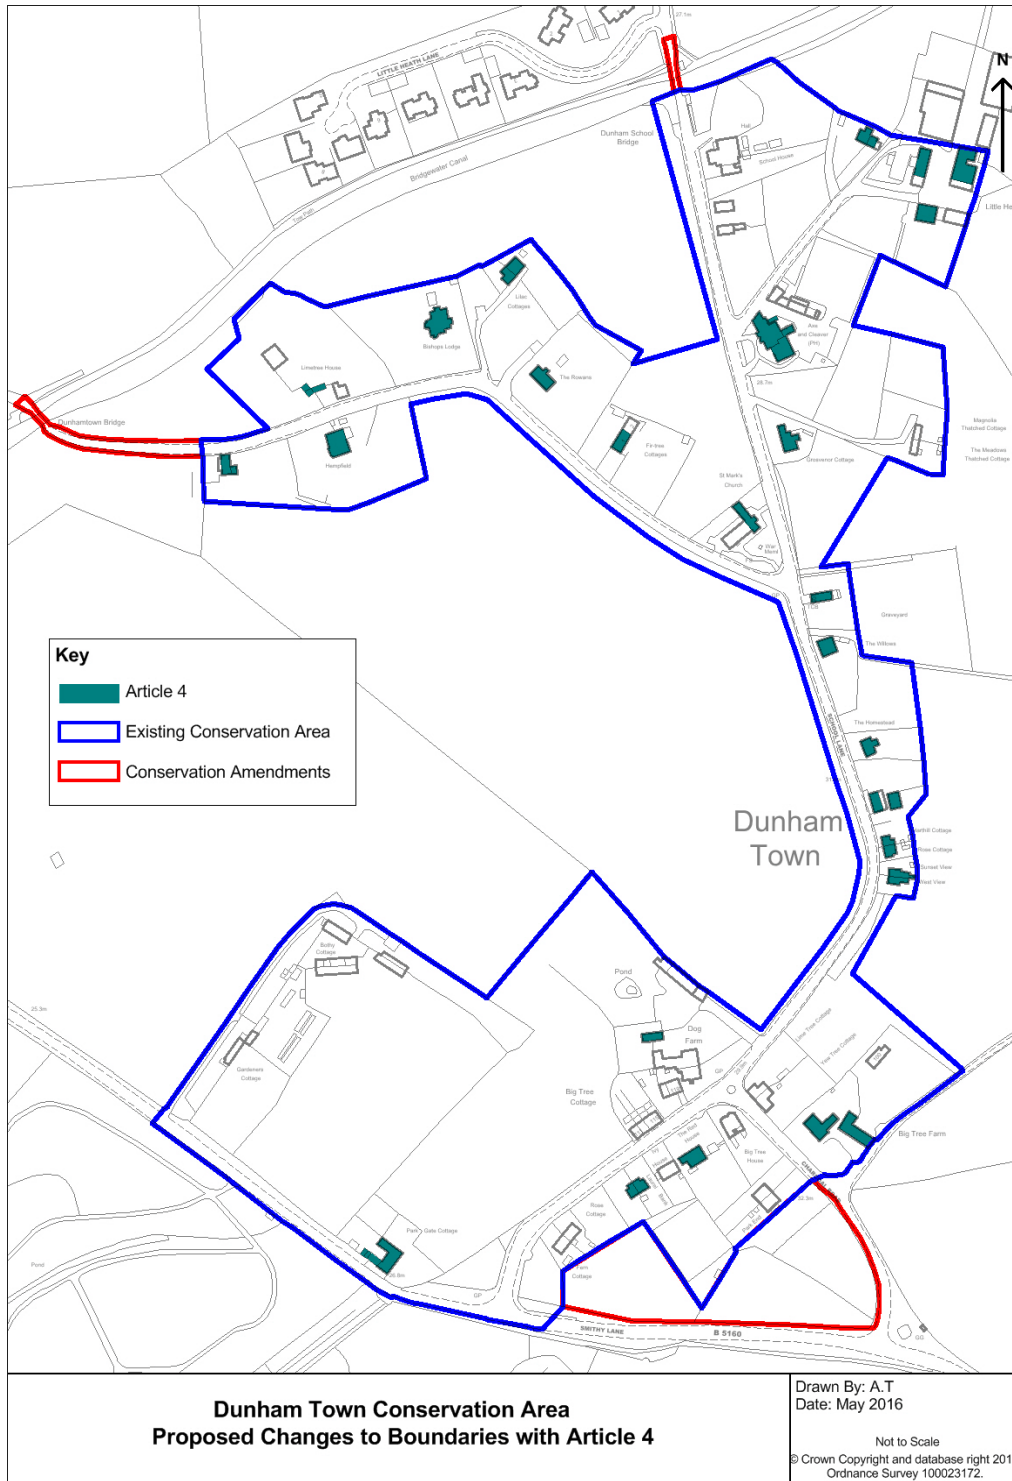
Map 11: Dunham Town Conservation Area boundary extensions adopted 2016 including potential Article 4 Directions

- 7.1.3 **Extension Areas A and B:** The boundary is extended to include both Dunham Town Bridge and Dunham School Bridge on School Lane and Back Lane, respectively. The bridges are important historic structures inextricably linked with the cutting through of the Bridgewater Canal in 1776 and, by association, the industrialisation of Greater Manchester. They are a key historical feature within the village.

- 7.1.4 **Extension Area C:** At the south-east corner of the present Conservation Area the remaining section of the triangular plot bounded by Smithy Lane, Charcoal Road and Woodhouse Lane is included in the Conservation Area. This was historically part of the park at Dunham Massey until relatively recently when the bypass was cut through. The park was listed around the same time; however, this area has not been recognised in the registered park boundary. A section of the original park boundary wall still survives in the plot now included in the Conservation Area.

- An Article 4 direction is recommended as an appropriate way to address issues with loss of traditional features. In the Dunham Town Conservation Area this would cover windows, doors, rainwater goods and small curtilage agricultural buildings for the properties listed below and shown on map 11 (page 77). Further detail will be provided in the forthcoming Management Plan.
